**Comp #: 490 Clubhouse Plumbing - Repair/Replace**

# Marina

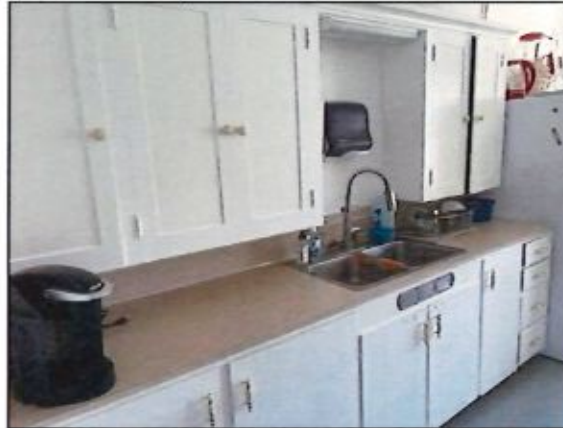
**Comments:** Until a qualified engineering firm has performed an evaluation of your plumbing systems, and provided specific recommendations, there is no predictable basis for system replacement reserves funding at this time.

Manufacturing defects become apparent from time to time, and certain site conditions (e.g. galvanic corrosion, dissimilar metals in contact with piping, chemical reactions, etc.) can contribute to premature deterioration of the plumbing systems.

Treat minor repairs as an ongoing maintenance expense.

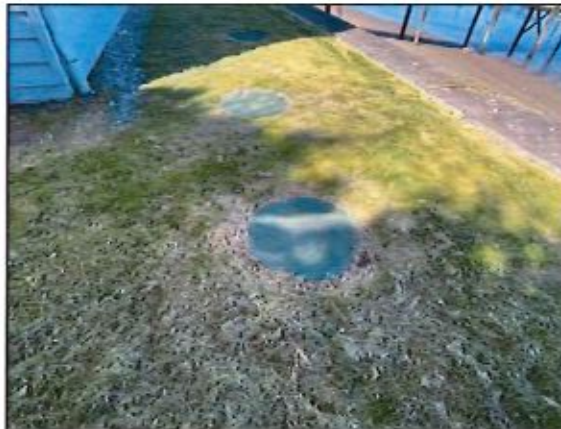
**Comp #: 493 Clubhouse Septic System - Repair/Replace**

**Comments:** No issues were reported of the septic system.

It is assumed that the clubhouse septic system is maintained similar to the individual residents and is pumped regularly. The Association maintains a maintenance allowance for larger scale septic system repairs. Keep track of actual expenses and update future reserve studies as needed.

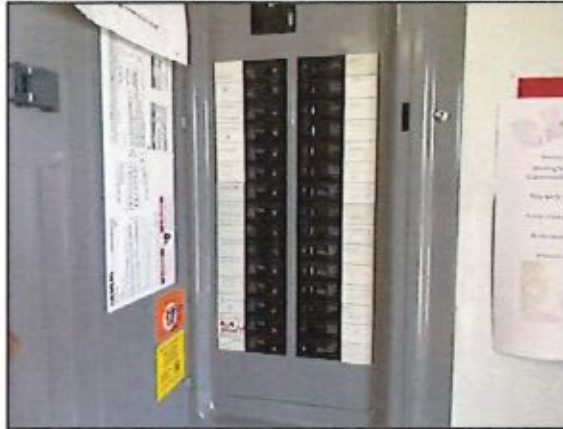
**Comp #:** 495 Clubhouse Electrical System - Modernize

**Comments:** The majority of the electrical system is not visible for review. Analysis of the electrical system, beyond a limited visual review, is not within the scope of a reserve study. No large issues or problems/defects were reported.

We recommend periodic evaluation by engineer/master electrician to evaluate the system for safety, code-compliance, maintenance, and repair and replacement needs. Any predictable expenses identified that meet the criteria for reserves funding can be included in the reserves plan. Some electrical system components are known to be life limited. Manufacturing defects become known from time to time, and certain site conditions can contribute to premature deterioration of electrical components.

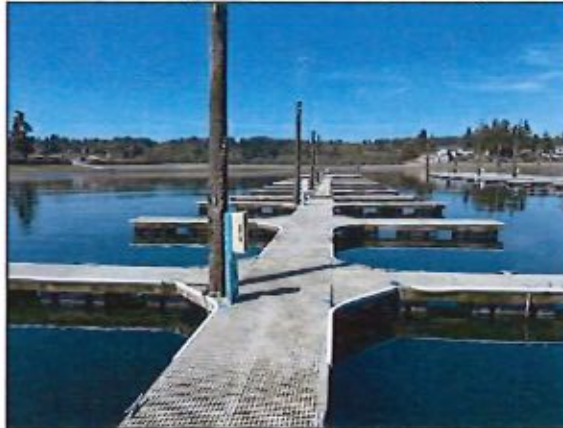
**Comp #: 1101 Mooring Dock A - Replace**

**History:** 2025-Partial replacement, added bollards and plumbing at \$335K; 2022, 2021, 2018-Partial replacements at \$110,000; 2014-Main section replaced;1974-Installed

**Comments:** The Association reported plans to replace remaining old section of mooring dock A in 2025 (~1,900 SF including 6 fingers). Bollard lights will replace overhead lighting, and brass water outlets will be added.

Replacement estimate, below, is for eventual full replacement of the dock, including bollards and plumbing.

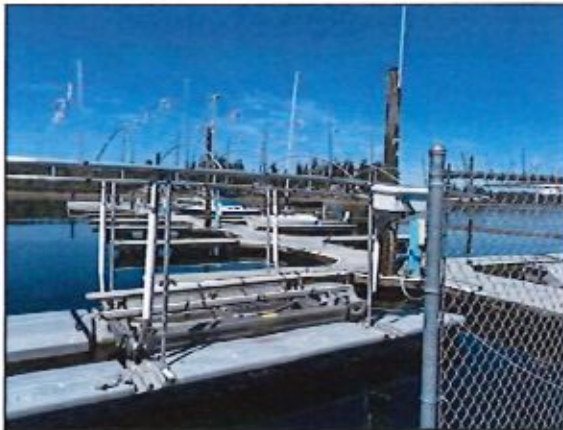
**Comp #: 1103 Mooring Dock B - Replace**

**History:** 2022-Remaining dock and floats replaced \$131K; 2021, 2018-Partial replacement

**Comments:** The dock and fingers of Dock B have been replaced incrementally since 2018. Funding is provided, below, for replacement of the dock and floats, including bollards and plumbing, based on estimates provided for Dock A in 2025.

Additional work may be added to Dock B to install bollards and plumbing. As these plans are developed, include funding in future reserve studies.

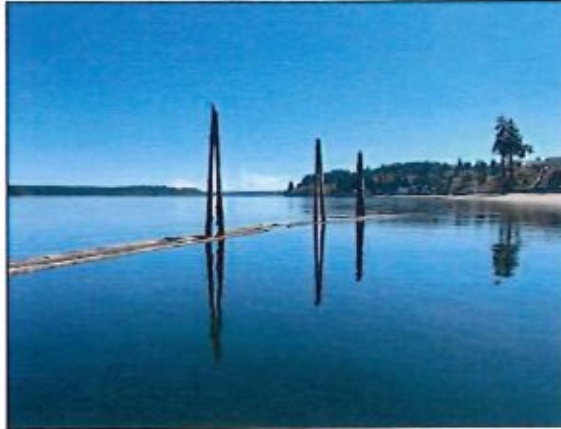
**Comp #: 1105 Log Boom - Repair/Replace**

**Comments:** The Association reported that the log boom was due for repairs and partial replacements.

Funding is provided, below, for cyclical repairs and replacements of the log boom. Keep track of actual expenses and update future reserve studies accordingly.

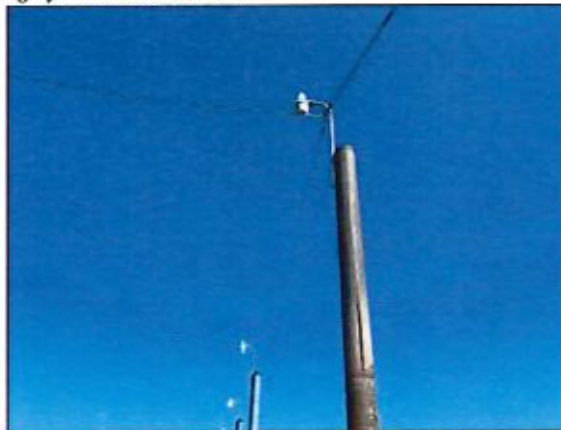
**Comp #: 1110 Marina Metal Pilings - Replace**

**Comments:** No problems were reported of the metal pilings.

While the useful life of the metal pilings may extend beyond 50 years, due to the corrosive nature of seawater, we recommend budgeting for replacements at roughly the timeline below.

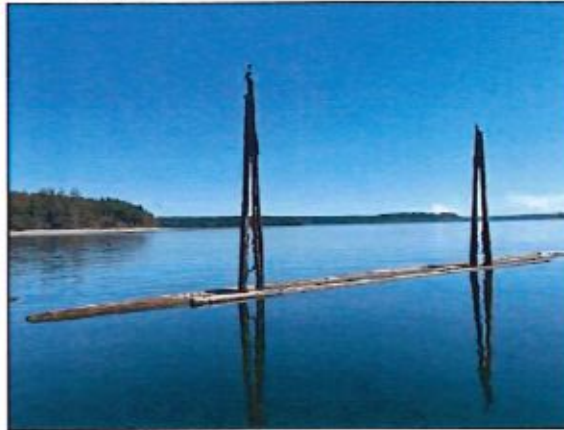
**Comp #: 1111 Marina Wood Pilings - Replace**

**Comments:** No professional evaluation of the wood pilings was available at the time of this report. Previous Association documents indicate that the replacement of the wood pilings with required metal pilings was anticipated in 2025/26, but no plans had been made.

Funding is provided, below, for the replacement of the wood pilings in the current fiscal year. Future reserve studies can be updated as evaluations and plans are finalized.

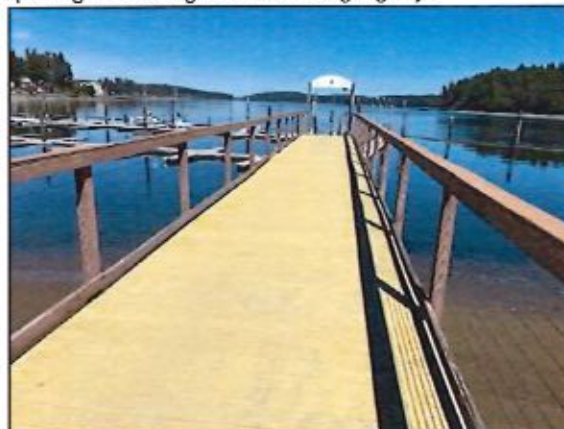
**Comp #: 1114 Marina Wood Gangway - Rpr/Rplc**

**Comments:** No problems were reported regarding the structure of the wood gangway. The surface of the gangway appeared worn of it's exterior surface. The metal cables on the railings appeared to be loose, allowing for penetration of larger objects. We recommend that the cables be tightened as a health and safety precaution.

Funding is provided, below, for replacing the walking surface of the gangway.

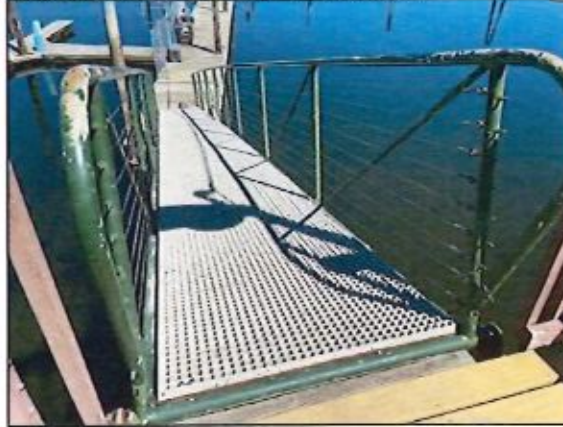
**Comp #: 1115 Marina Metal Gangway - Repair/Replace**

**Comments:** No problems were reported of the metal gangway leading to the main dock. The railings showed loss of paint coverage with some rust showing through. The gangway should be evaluated by a qualified engineer.

Funding is provided, below, for replacing the aluminum gangway and grating.

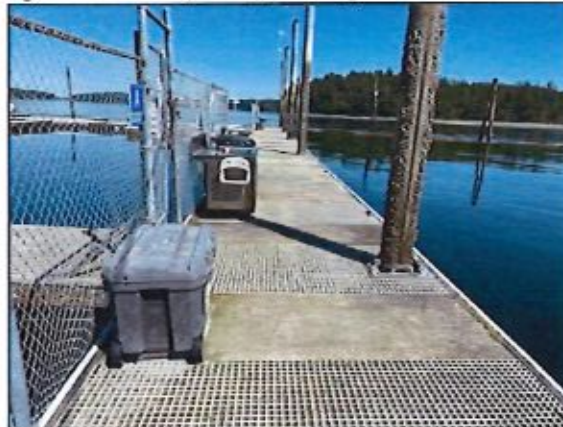
**Comp #: 1116 Main Floating Docks - Repair/Replace**

**Comments:** No problems were reported of the main floating dock of the marina. The condition of the dock is best determined by a qualified engineer. The remaining useful life is set, below, according to Association documents and historical satellite imagery.

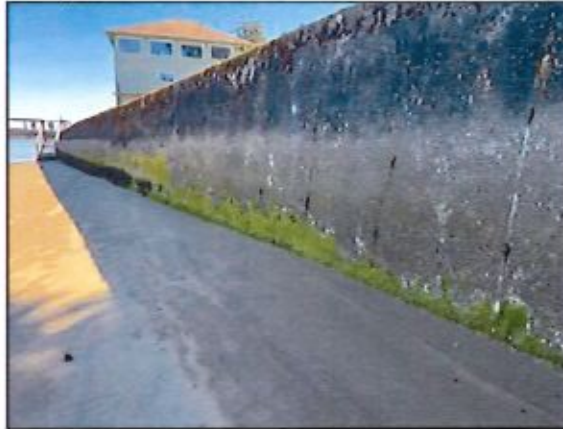
**Comp #: 1120 Bulkhead Retaining Walls - Repair**

**Comments:** Association documents indicate a partial repair of the bulkhead in 2014, with the remaining repairs due in 2026. The concrete wall showed some disintegration and areas of rust showing through cracks in the walls.

We recommend a professional evaluation by a qualified engineer to establish a maintenance and repair plan for the bulkhead. Funding is provided, below, based on previous Association documentation.

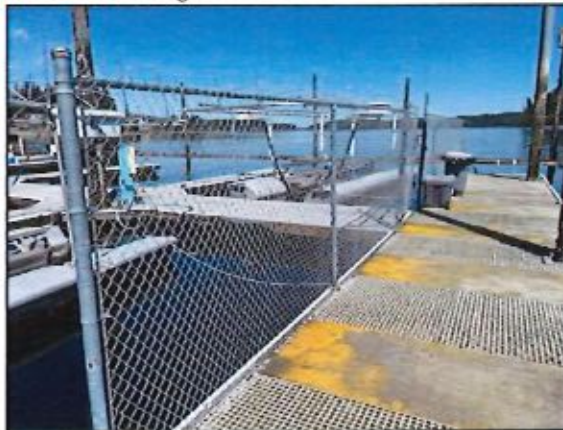
**Comp #: 1144 Chain Link Fence - Repair/Replace**

**Comments:** For financial planning purposes, plan on replacing at roughly the time frame shown below. Evaluate the fence as the remaining useful life approaches zero years, and adjust the remaining useful life accordingly.

Chain link fencing is generally a low maintenance item. Inspect periodically, and repair as needed. If corrosion is observed, apply a rust inhibitor to prevent corrosion from decreasing the useful life.

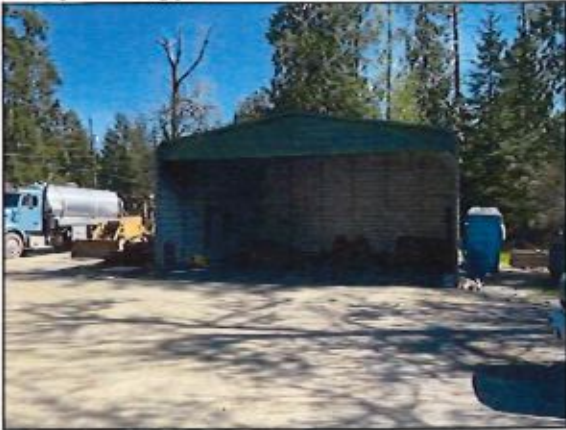
**Comp #:** 2100 Carports - Repair/Replace

**Comments:** No problems were reported of the metal car port.

Inspect regularly and repair, as needed, with operating funds. Evaluate the condition of the carport as remaining useful life approaches 0 and update reserve study accordingly.

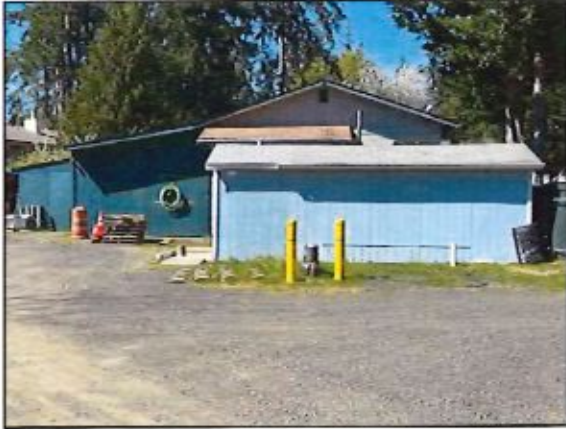
**Comp #:** 2500 Maintenance Roof - Repair/Replace

**Comments:** Observation of the rooftops was limited during our site review. No problems were reported.

Evaluate the condition of the roof as remaining useful life approaches 0 and update reserve study accordingly.

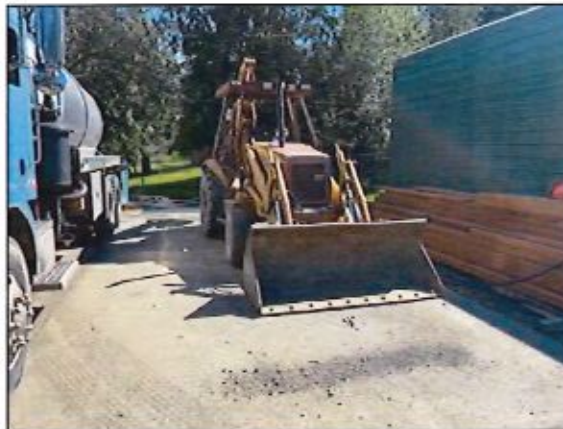
**Comp #:** 2511 Backhoe - Replace

**Comments:** Association documents show that the backhoe is repaired as an operating expense as needed. Replacement with a used backhoe is planned for 2028.

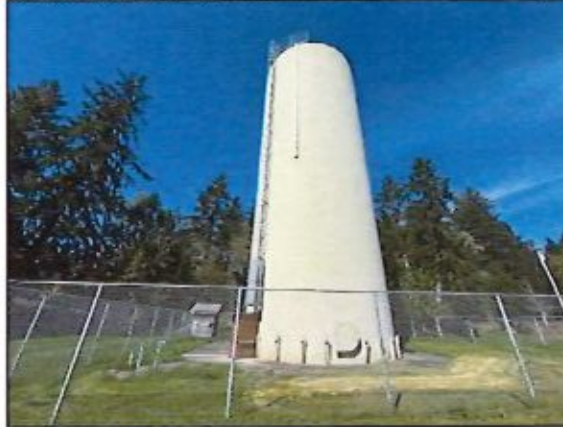
**Comments:** The Association plans to paint the exterior of the water tower in 2025/26 to protect the surface from corrosion.

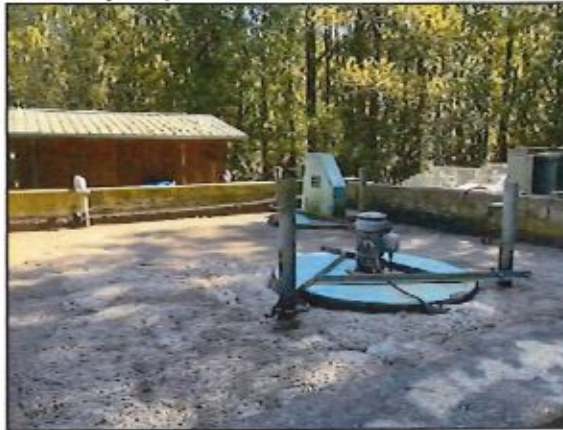
**Comp #:** 4110 Decanter Unit - Replace

**Comments:** The waste water treatment facility has two decanter units. This budget provides funds to replace one decanter unit every 10 years, for a total Useful Life of 20 years per decanter.

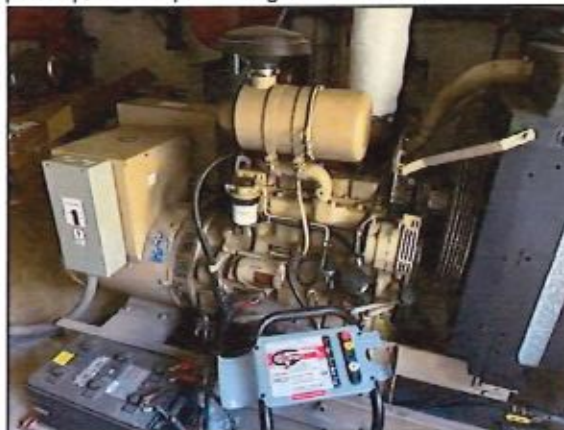
**Comp #: 4155 WW Generator - Repair/Replace**

**Comments:** The Association reported plans to replace the generator in 2025.
