Update “With Site-Visit” Reserve Study

Sunrise Ridge/The Highlands at Somerset Hill

Tumwater, WA

Report #: 23122-1

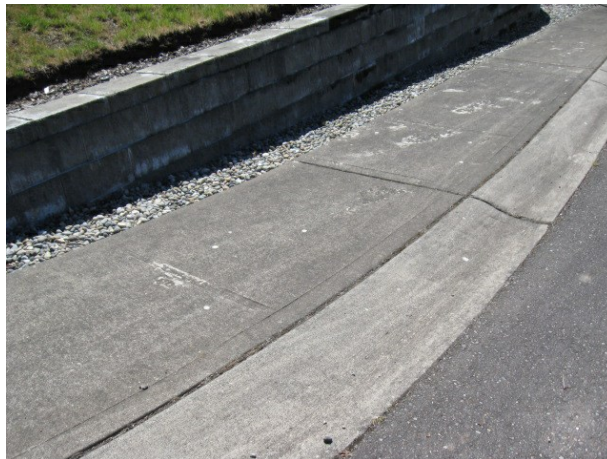
Comp #: 100 Concrete/Curbs - Repair/Replace **Quantity:** ~ 36,000 GSF
sdwlks/curbs

Evaluation: No major cracking/damaged noted of concrete rolled curbs and gutters noted. No trip hazards were observed. Repair any trip and fall hazards (1/2" or larger displacement) immediately to ensure safety.

Useful Life:
5 years

Remaining Life:
2 years

In our experience, larger repair/replacement expenses emerge as the community ages. Although difficult to predict timing, cost and scope, we suggest a funding allowance to supplement the operating/maintenance budget for periodic larger repairs. Adjust as conditions, actual expense history indicates within future reserve study updates.

As routine maintenance, inspect regularly, pressure wash for appearance and repair promptly as needed to prevent water penetrating into the base and causing further damage. Monitor tree roots nearby; consult with arborist for best practice.

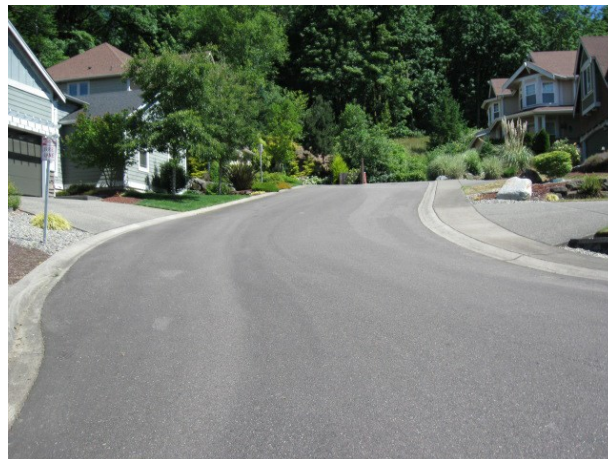
Useful Life:
35 years

Remaining Life:
23 years

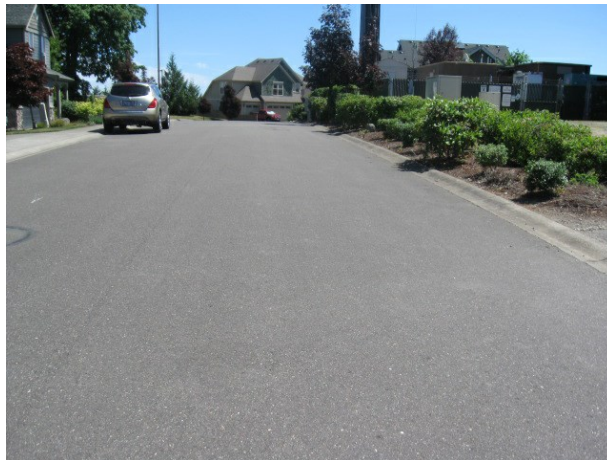
Comp #: 121 Asphalt - Clean/Repair/Sealcoat Quantity: ~ 116,400 GSF

Useful Life:
5 years

Remaining Life:
0 years

Repairing asphalt before seal coating is imperative. Surface preparation and dry weather during and following application, is key to lasting performance.

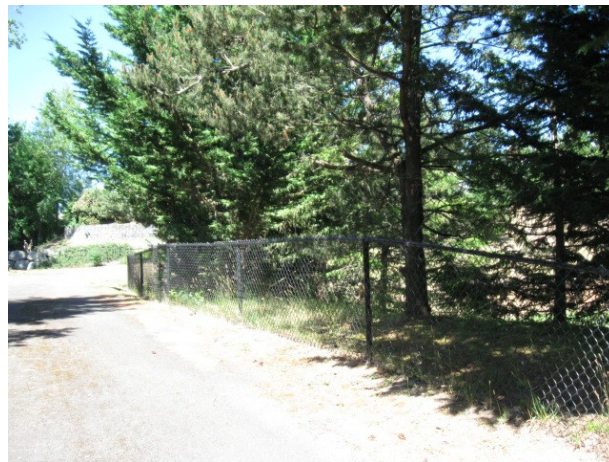
Comp #: 144 Cyclone Fencing - Replace

Useful Life:
30 years

Remaining Life:
17 years
