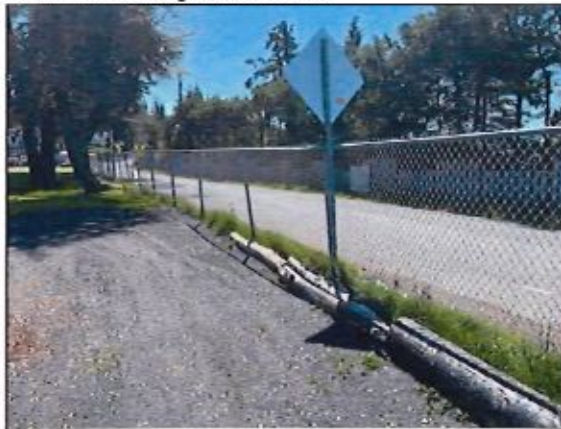
Comp #: 144 Chain Link Fence – Repair/Replace

Comments: The galvanized chain link fences did not appear to have large areas of damage.

Chain link fencing is generally a low maintenance item. Inspect periodically, and repair as needed. If corrosion is observed, apply a rust inhibitor to prevent corrosion from decreasing the useful life.

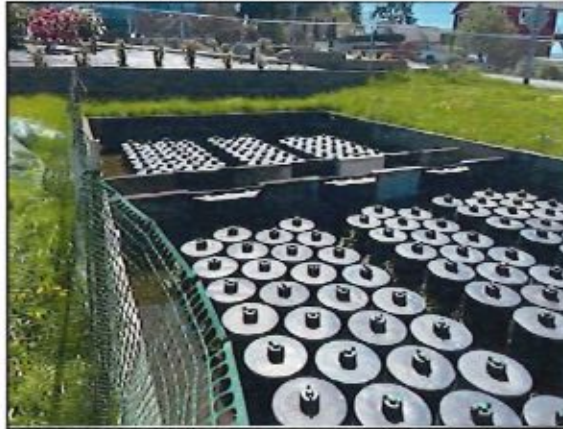
Comments: The stormwater pond and bio-filter park has two vaults that are exposed. The Association reported that the facility is maintained annually with the replacement of 1/3 of the filters, and inspected every three years.

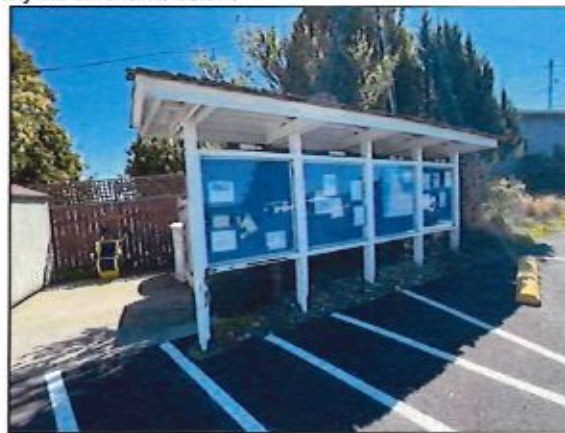
Comp #: 196 Information Kiosk - Repair/Replace

Comments: The information kiosk at the entrance of the clubhouse is of a wood structure with a decorative wood shingle roof. The structural posts of the kiosk were showing advanced decay. As much of the decay may be covered by soil at the base of the posts, we urgently recommend that the kiosk be replaced as a health and safety precaution.

Inspect regularly, clean, and repair promptly utilizing operating funds. Paint the kiosks simultaneously as the buildings. Expect to replace the kiosks at approximately the timeframe below.

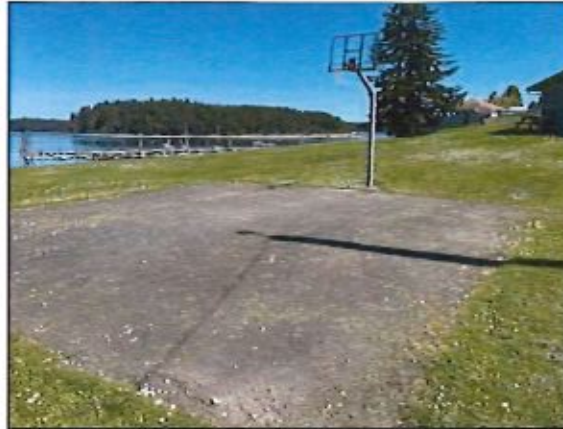
Comments: The informal asphalt sport court showed a small area of sloughing at one of the edges. The metal frame basketball assembly did not appear to have any damage.

As regular maintenance, inspect the sports court for any hazardous conditions, clean the surface of debris and organic growth, and inspect the basketball assembly for damage. Repair or replace components as needed as an operating expense.

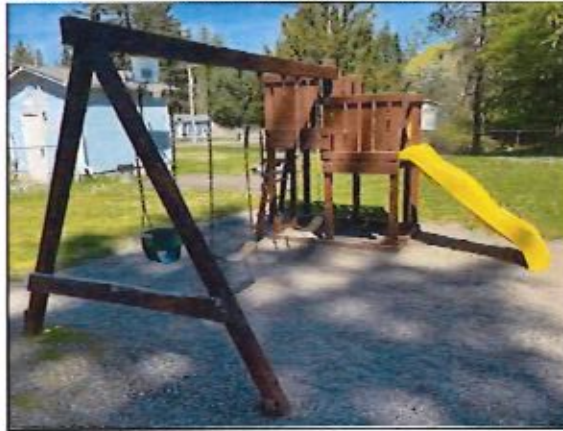
Comp #: 339 Westwind Play Equipment - Rpr/Replace

Comments: The wood construction play equipment did not appear to have damage, and no problems were reported.

Replacement cycles vary depending on the amount of use/abuse, however, expect to complete an extensive park area renovation at roughly the time frame listed below. Inspect for stability, damage and excessive wear, and utilize operating funds for any repairs needed between replacement cycles.

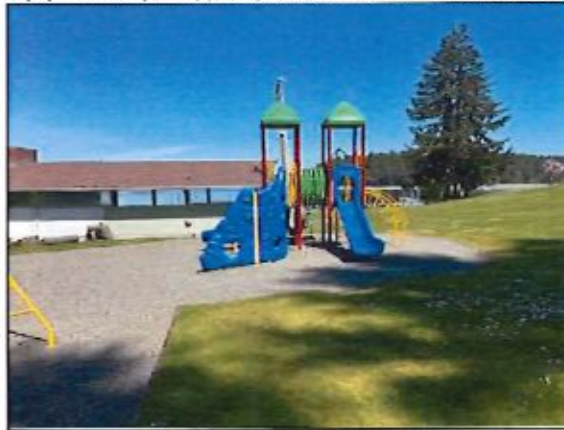
Comp #: 340 Waterfront Play Equipment - Rpr/Rplc
Location: Waterfront play equipment - metal and plastic construction
Funded?: Yes.
History: 2021-Replaced \$20K
Comments: The metal and plastic construction play equipment did not damage, and no problems were reported.

Replacement cycles vary depending on the amount of use/abuse, however, expect to complete an extensive park area renovation at roughly the time frame listed below. Inspect for stability, damage and excessive wear, and utilize operating funds for any repairs needed between replacement cycles.

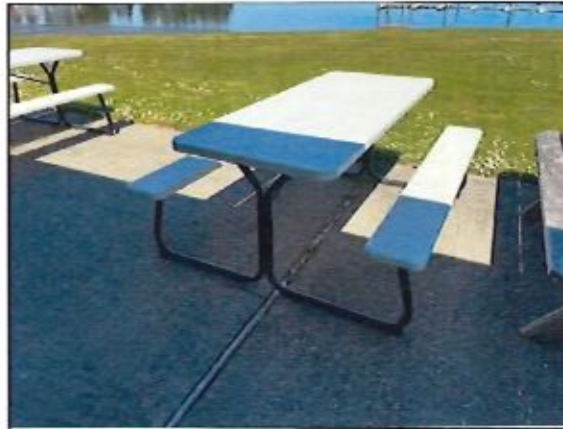
Comp #: 346 Site Furniture - Repair/Replace

Comments: Wood and metal/composite picnic tables and benches within the park areas appeared to be in varying condition and age.

Inspect regularly, and repair or replace as needed with operating funds. Clean with an appropriate cleaner (refinish if desired) using operating funds.

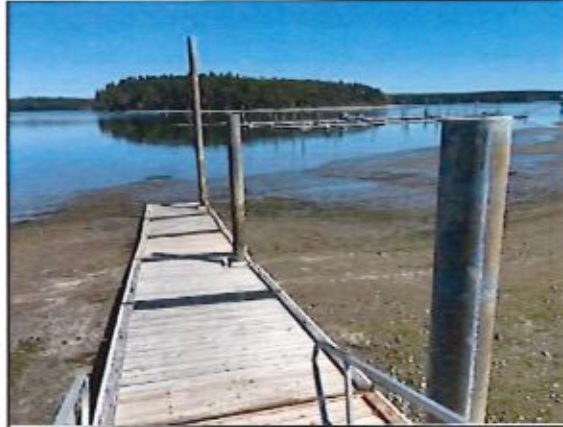
Comp #: 352 Floating dock - Repair/Replace
Location: Wood floating dock for small boat launch
Funded?: Yes.

Comments: Pressure treated wood floating dock with two metal piers and one wood pier. The protective sealant on the wood appeared faded and worn, and the wood appeared exposed to the elements.

Note that if decking products are treated with formulations such as ammoniacal copper zinc arsenate (ACZA) and chromated copper arsenate (CCA) they are no longer recommended in aquatic applications due to environmental concerns. Inspect regularly, clean for appearance, seal wood where appropriate and provide spot repair promptly as needed from operating budget. Compliance with any and all governmental regulations regarding the construction, maintenance or repair of these types of docks is assumed. We recommend planning for intervals of significant replacement for deck boards, floats, structural members, etc...at roughly the 25-35 year time frame indicated below. Track needs/pattern of expenses carefully and update in future reserve study updates as conditions merit.

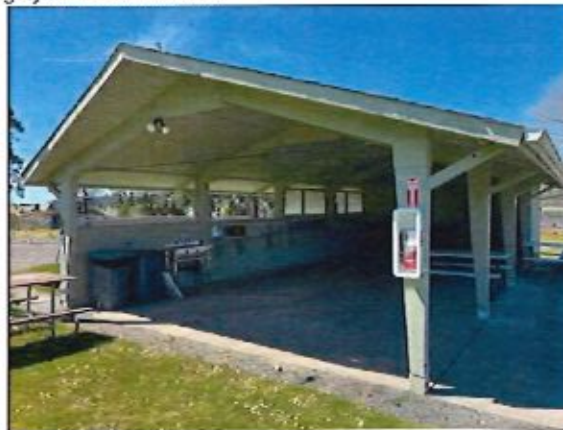
Comp #: 360 "Wanigan" - Repair/Reroof

Comments: Repairs on the "wanigan" were done in 2024 at \$5.5K to address some structural decay and siding replacement. The roof was reported to have been replaced in 2015.

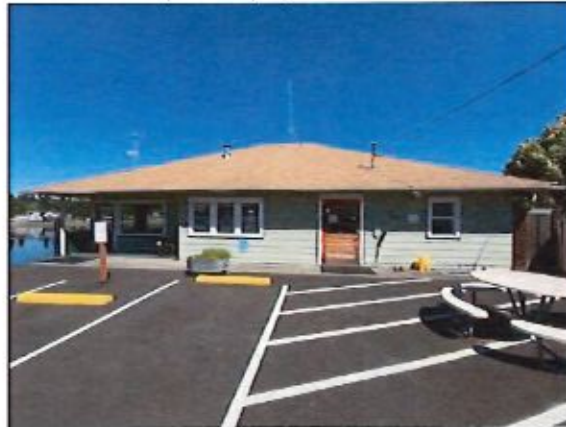
Comp #: 400 Clubhouse Roof - Repair/Replace

Comments: Roof ventilation (the lack of which can greatly reduce the roof's useful life) was observed at the eave. Eave venting consisted of 2 drill holes in the blocking between the rafters. Gutters blocked the view of the eaves, so eave flashing was not confirmed. Debris and moss were not observed on the roof surface. A reserve study conducts a limited visual review for budget purposes, and many of the critical waterproofing and ventilation items of the roof are not readily viewable. For a full evaluation have a professional roof consultant/contractor perform a thorough up-close survey of your entire roof system, including attic inspection (if any).

As routine maintenance, many manufacturers recommend inspections at least twice annually (once in the fall before the rainy season, and again in the spring), and after large storm events. Promptly replace any damaged/missing sections and complete any other repairs needed to ensure the waterproof integrity of the roof. Keep the roof surface, gutters, and downspouts clear and free of moss and/or debris.

At the time of re-roofing, we recommend that you hire a professional consultant to evaluate the existing roof, specify the new roof materials/design, and provide installation oversight. We recommend that all associations hire qualified consultants whenever they are considering having work performed on any building envelope (waterproofing) components including the roof, walls, windows, decks, exterior painting, and caulking/sealant.

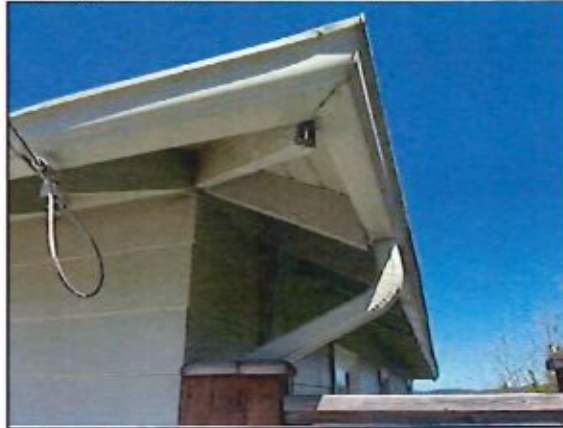
Comp #: 406 Clubhouse Gutters - Repair/Replace

Comments: Based on our limited visual inspection, the metal gutters and downspouts appeared functional. Some leaking at seams was noted.

We recommend planning for a total replacement of the gutters and downspouts at the same intervals as roof replacement for cost efficiency. Evaluate these components at the time of the project to determine if replacement or re-use is the better value.

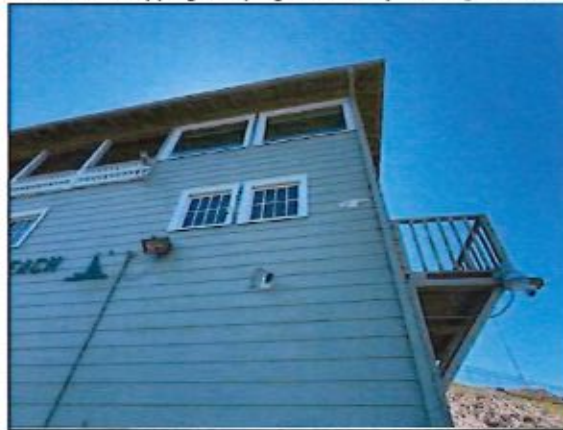
Comments: The wood siding is horizontal clapboard, and the surface is painted (see component #412 for exterior painting). No view of the critical underlying waterproofing was available as part of our limited visual review. Portions of the wood showed wear, with local areas of decay. With the exposure to marine weather, we recommend that the Association obtain an envelope study from a qualified engineer to assess the condition of the siding and weather proofing, and the scope of work for any repairs and ongoing maintenance.

Replacement may ultimately be needed due to the failure of the underlying waterproofing degrading over the decades, and/or the end of the useful life of the siding materials from general aging. Many factors influence the useful life, including exposure to (or protection from) wind driven rain, and the quality of the waterproofing and flashing beneath the siding. Evaluate the siding and the critical underlying waterproofing (typically building paper or house-wrap) more frequently as the remaining useful life approaches zero years. Adjust the remaining useful life as dictated by the evaluation. When practical, align siding replacement with window replacement for cost efficiencies and building envelope integrity. Inspect annually, and repair locally, as needed, using general operating maintenance funds. Keep the wood siding painted to protect it from water decay - see component #533.

Another item that greatly influences the useful life is the thoroughness of the original painting. Wood siding will last longer if each piece was painted on all six sides. Typically, wood siding is painted on the two sides that are exposed, and not on the back, ends, or top. Since we perform only a visual review, we were unable to confirm the extent of the painting. It is reasonable to presume that not all six sides are painted. If the siding is not painted on all sides, water can infiltrate, and be absorbed into the wood on the unpainted sides, which over time will lead to cupping, warping, and decay, limiting its useful life.

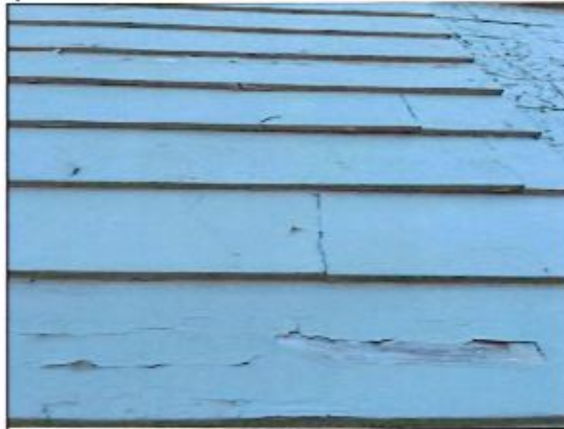
Comments: The exterior paint showed wear, peeling and chalking.

Proper sealant/caulking is critical to keeping water out of the walls, and preventing water damage. Incorrect installation of sealants is very common, and can greatly decrease its useful life. Inspect sealants (more frequently as they age) to determine if failing is occurring. Typical sealant problems include failure of the sealant to adhere to adjacent materials, and tearing/splitting of the sealant itself. As sealants age, and due to exposure to ultraviolet sunlight, they will dry out, harden, and lose their elastic ability. Remove and replace all sealants at the time sealant failure begins to appear. Proper cleaning, prep work, and installation technique (shape, size, tooling of joint) are critical for a long lasting sealant/caulking. Do not install sealant in locations that would block water drainage from behind the siding (e.g. at head flashings).

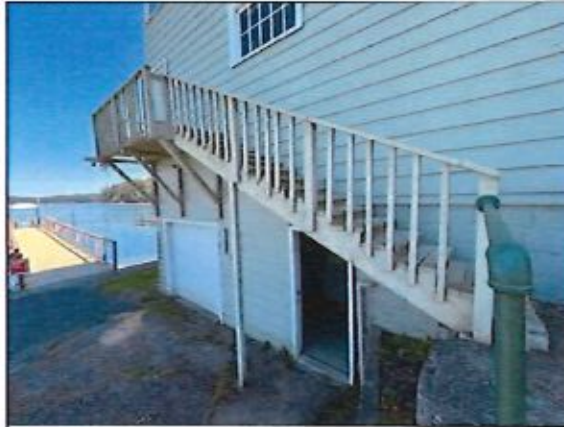
Comp #: 413 Clubhouse Stairs - Repair/Replace

Comments: The stair stringers are wood, and the stair treads are attached to the stair stringer by steel angle and bolts. The railings are wood. The stair was closed to access due to unsafe condition of the structure. We strongly recommend replacing the stairs as a health and safety precaution.

As routine maintenance, inspect regularly to ensure safety and stability. Repair promptly, as needed, with operating funds. Paint as a part of an exterior paint project - see component #533. Treat corroded metal with a rusted inhibitor to extend the useful life.

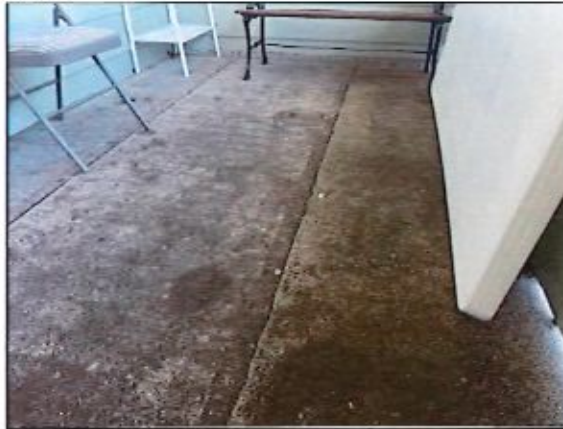
Comments: The surface of the deck appeared to be a modified bitumen. The drip edge of the deck is partially open. A vertical portion of drip edge flashing was not observed. The threshold of the door is not raised slightly above the deck surface to allow proper flashing. Venting on the underside of the deck, at the soffit below, was not observed. Venting is a good practice as it can reduce problems from condensation. The railing connections do attach through the deck surface. The fewer penetrations through the waterproof surface, the fewer opportunities there are for water penetration.

We recommend that the Association have a qualified engineer evaluate the deck for a scope of repairs to the substructure of the deck and to determine the best surface to apply to this deck. Funding provided, below, does not take into account any needed structural repairs or redesign of the railings. Once the surface of the deck is installed, funding can be added for regular maintenance required for that surface.

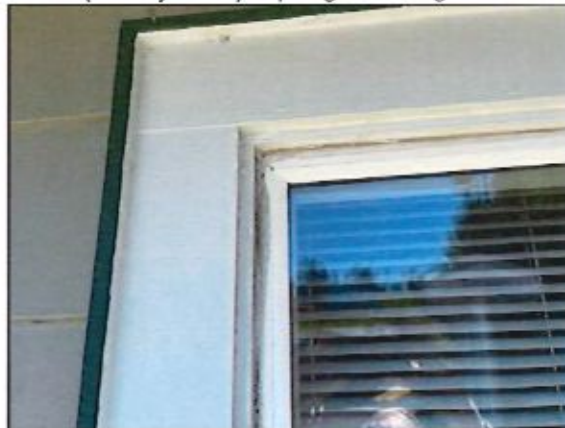
Comp #: 415 Clubhouse Windows - Repair/Replace

Comments: The clubhouse windows vinyl windows inserted into a wood framing, using caulk as a sealant. Head flashing was not observed. The jambs and sills had failing sealant joints between the window frame and cladding . No observation of the critical underlying waterproofing details and flashing was part of our limited visual review. The underlying details and flashing are critical to maintaining the waterproofing of the building envelope and preventing structural damage as a result of water infiltration. A reserve study is a budget model, limited to visual exterior observation and research. It is outside the scope of our services, and the purpose of a reserve study, to assess the adequacy of the building envelope performance, as many of the key details are hidden from view. Periodic reviews by an architect, building envelope professional, etc. are prudent.

Inspect regularly, including sealant, if any, and repair as needed. Typical sealant failures include a lack of adhesion to adjacent materials, tearing/splitting of the sealant itself, and loss of elastic ability. Loss of elastic ability can be caused by exposure to ultraviolet light, and general aging. Remove and replace all sealants as signs of failure begin to appear. Proper cleaning, prep work, and installation of specified joint design are critical for lasting performance. Keep weep holes free and clear to allow proper drainage of water that gets into the window frame. Do not block (caulk or seal) the gap at the top of head flashing, as this allows water that gets behind the siding to drain out.

We recommend the board conduct research well in advance of this project to help better define timing and costs (scope of work, material specifications, etc.). Further, we recommend that you hire a professional consultant (architect, engineer, building envelope consultant) to evaluate the existing windows, design and specify new installation requirements, assist with the bid process, and observe the construction to increase the likelihood of proper installation. We recommend all associations hire qualified consultants whenever they are considering having work performed on any high-risk building envelope components (roof, walls, windows, decks, exterior painting and caulking/sealant).
