Sunrise Ridge/The Highlands at Somerset *Tumwater, WA*

Report #: 23122-3
Beginning: January 1, 2023
Expires: December 31, 2023

RESERVE STUDY Update "With-Site-Visit"

June 24, 2022

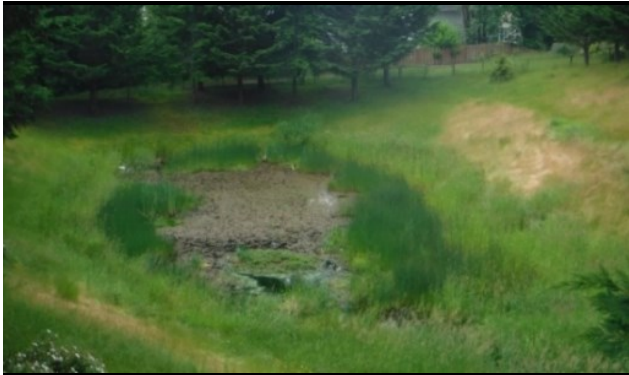
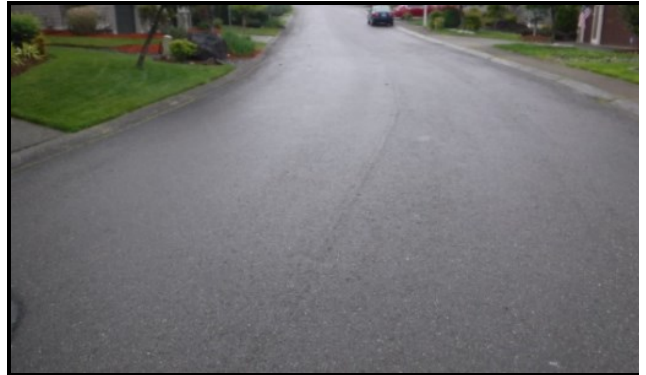
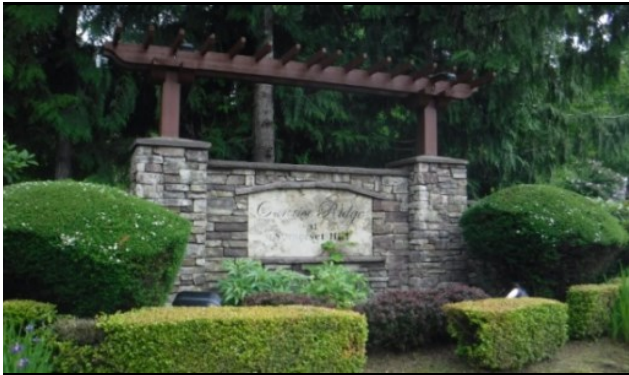
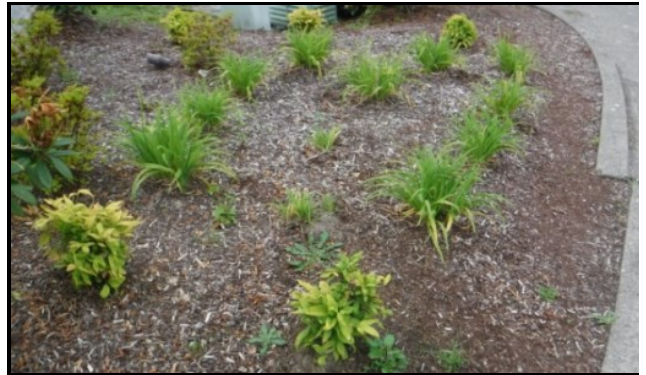
During our site visit on 6/16/2022, we visually inspected all visible common areas, while compiling a photographic inventory, noting: current condition, make & model information where appropriate, apparent levels of care and maintenance, exposure to weather elements and other factors that may affect the components useful life. No major deterioration throughout common areas with ongoing maintenance and work being conducted regularly.

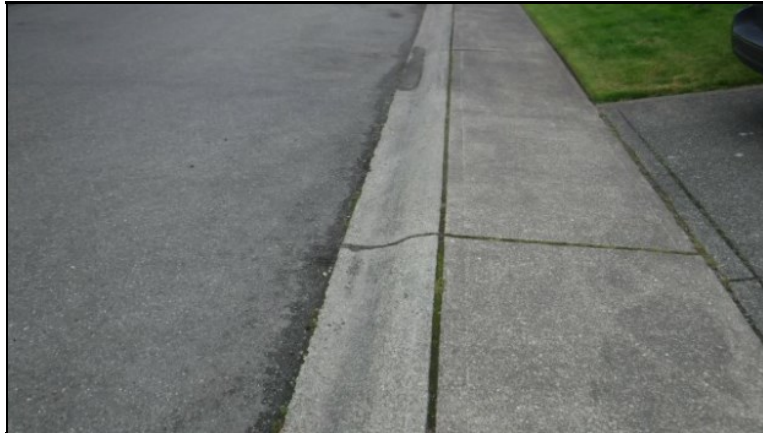
Comp #: 100 Concrete/Curbs - Repair/Replace

Comments: Like our previous site visit, dirt/grime observed on surfaces, however no major or widespread cracking/damaged noted of concrete rolled curbs and gutters and flatwork sidewalks.

In our experience, larger repair/replacement expenses emerge as the community ages. Although difficult to predict timing, cost and scope, funding allowance factored here to supplement the operating/maintenance budget. As routine maintenance, inspect regularly, pressure wash for appearance and repair promptly as needed to prevent water penetrating into the base and causing further damage. Repair any trip and fall hazards (1/2" or larger displacement) immediately to ensure safety. Monitor tree roots nearby; consult with arborist for best practice.

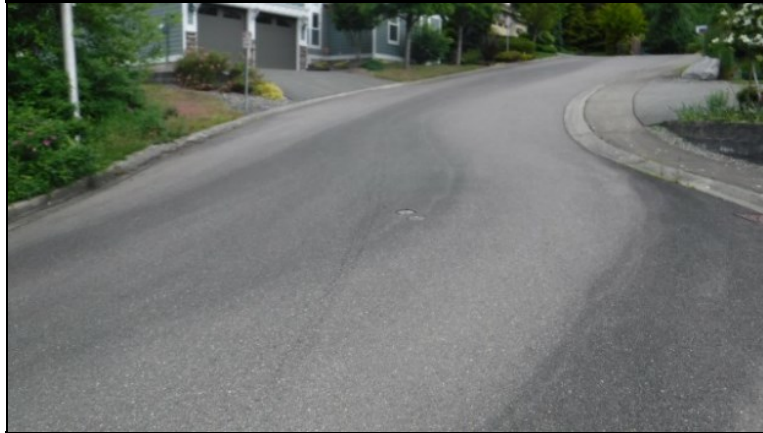
Comments: No major or widespread cracking/damage noted; some local cracks (crackfill planned for 2022 #121) and some raveling but majority is stable. No history of emulsion seal coating in this community with some local repairs/crackfilling having already occurred. As discussed with our board contact, routine sealcoat cycles are not part of the Association plans.

Factored here for long term is repave/resurface. The useful life here adjusted downward from previous reserve study as Association is not having sealcoating completed. When need to resurface is apparent within a couple of years, consult with geotechnical engineer for recommendations, specifications / scope of work and project oversight. As routine maintenance, keep surfaces clean and free of debris, ensure that drains are free flowing, repair cracks, and clean oil stains promptly.

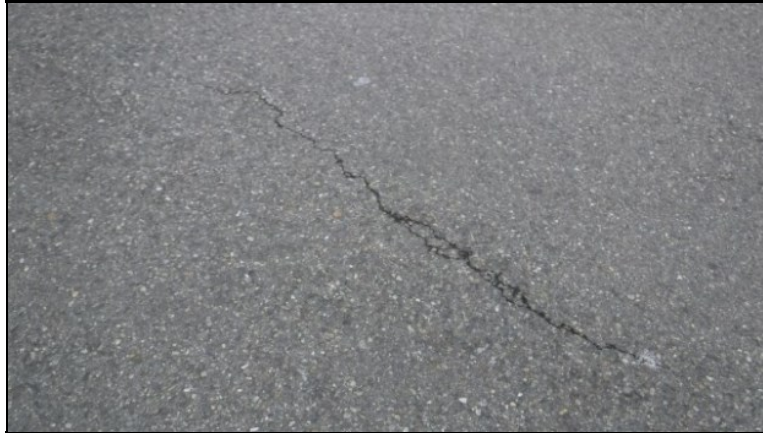
Comp #: 121 Asphalt - Clean/Repair/Crackfill

History: Crackfilling planned for 2022

Funding included here for periodic cleaning, repairing/crackfilling. This is in addition to annual inspections that might prompt work between these cycles. The costs/timing of this component can vary and should be adjusted as needed.
