## Sunrise Ridge/The Highlands at Somerset Tumwater, WA

Report #: 23122-4  
Beginning: January 1, 2026  
Expires: December 31, 2026

# RESERVE STUDY Update "With-Site-Visit"

June 9, 2025

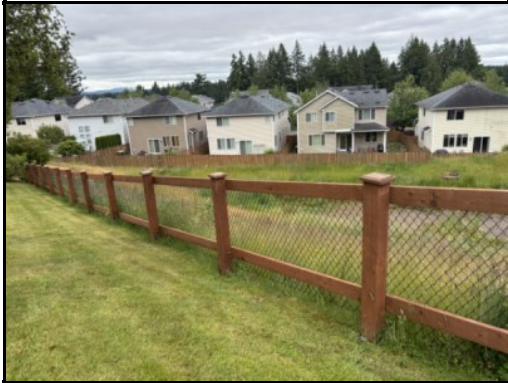
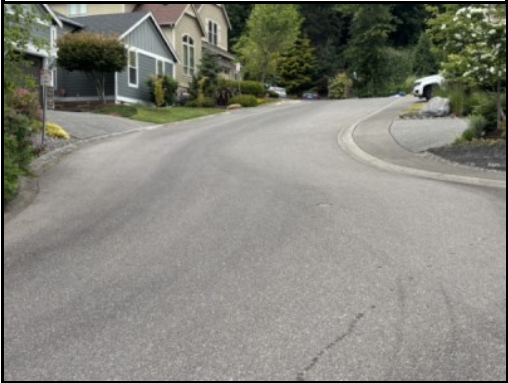
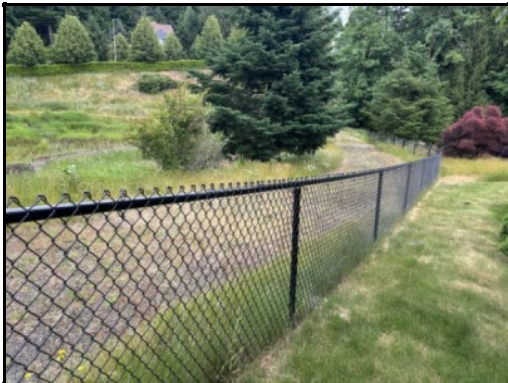
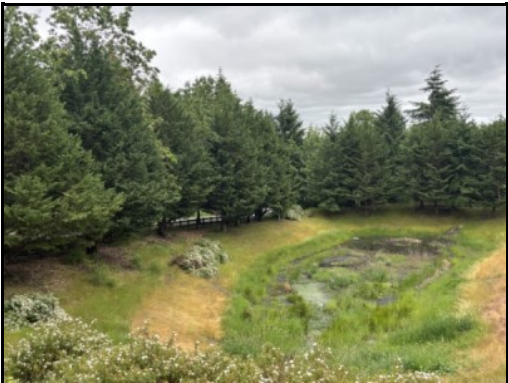
### Site Inspection Notes

During our site visit on 6/4/2025, we visually inspected all visible common areas, while compiling a photographic inventory, noting: general exterior observations, make & model information where appropriate, apparent levels of care and maintenance, exposure to weather elements and other factors that may affect the components useful life. Some new fencing has been added since the last reserve study and is included in the component list. Overall, no major problems noted of roads or ponds and none reported.

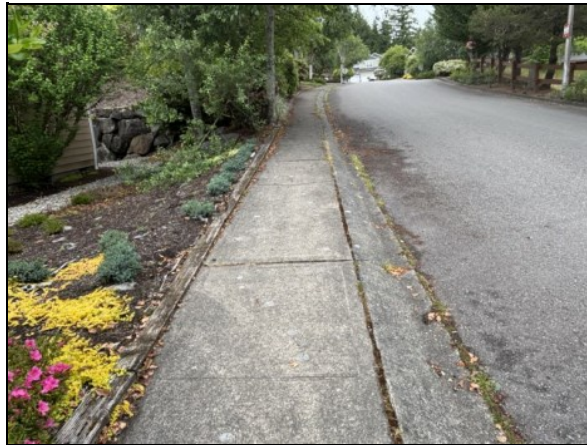
**Comp #: 100 Concrete/Curbs - Repair/Replace**

**Comments:** Surfaces have dirt/grime and some local repairs in the past including most recently in 2024 replacing a 4'X20' section of sidewalk. No widespread or major damage noted at this time of concrete rolled curbs and gutters and flatwork sidewalks.

In our experience, larger repair/replacement expenses emerge as the community ages. Although difficult to predict timing, cost and scope, funding allowance factored here to supplement the operating/maintenance budget. As routine maintenance, inspect regularly, pressure wash for appearance and repair promptly as needed to prevent water penetrating into the base and causing further damage. Repair any trip and fall hazards (1/2" or larger displacement) immediately to ensure safety. Monitor tree roots nearby; consult with arborist for best practice.

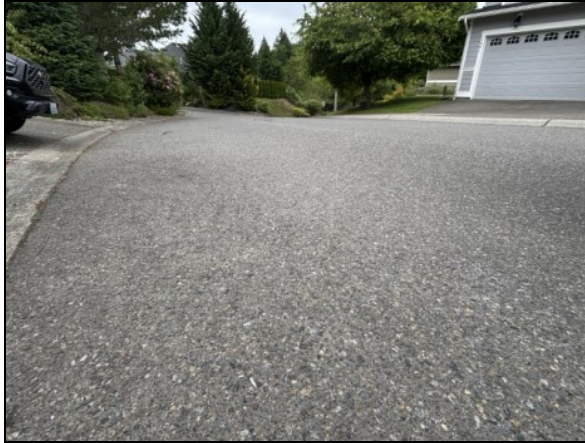
**Comments:** While no major damage noted, some raveling of surfaces and grayed appearance of routine sealcoat projects not completed. Periodic crack-filling in next component.

Factored here for long term is repave/resurface. The useful life here adjusted downward from previous reserve study as Association is not having sealcoating completed. When need to resurface is apparent within a couple of years, consult with geotechnical engineer for recommendations, specifications / scope of work and project oversight. As routine maintenance, keep surfaces clean and free of debris, ensure that drains are free flowing, repair cracks, and clean oil stains promptly.

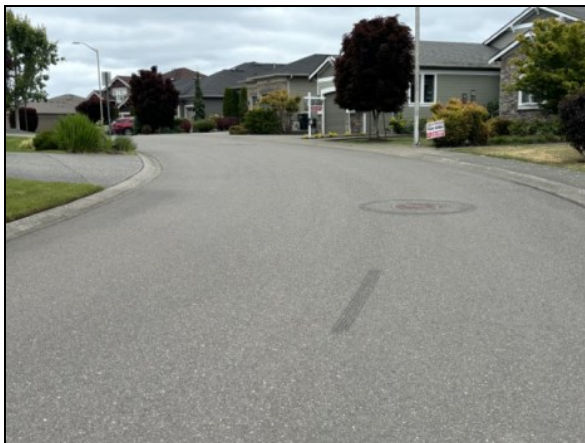
**Comp #: 121 Asphalt Roads - Clean/Repair/Crackfill**

**History:** Crackfilling in 2024 (\$1974), 2022 (\$1971)
