“Full” Reserve Study

The Highlands at Somerset Hill

Tumwater, WA

Report #: 23122-0

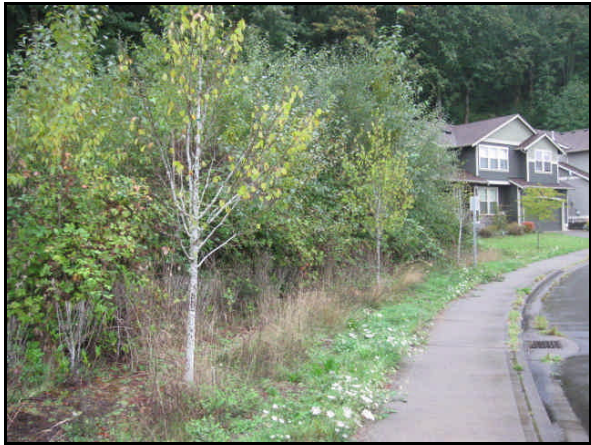
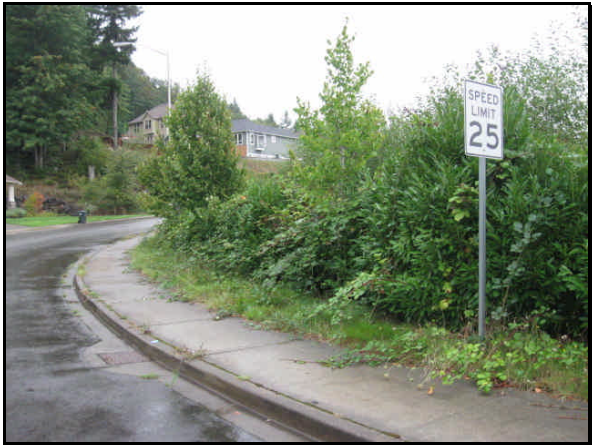
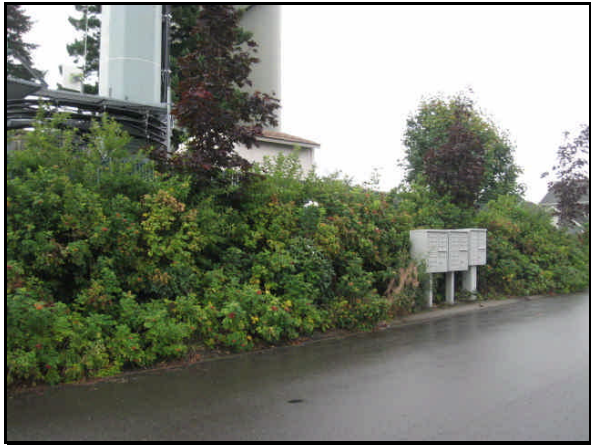
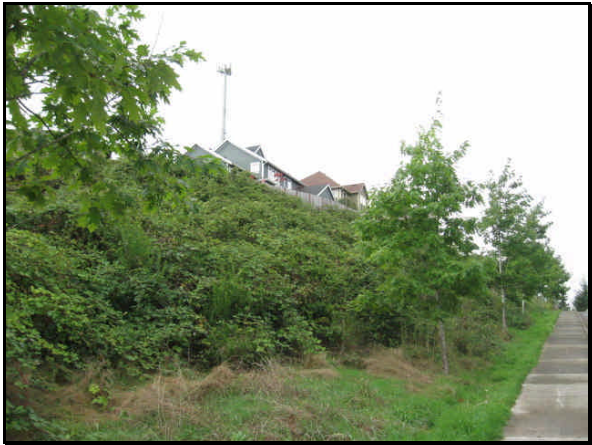
Construction for The Highlands at Somerset Hill began in 2006. It is our understanding that responsibility for the common areas was recently transferred to the Association and maintenance of some of the common areas (mainly landscaping and storm drainage tracts, see photos below) was deferred for many years.

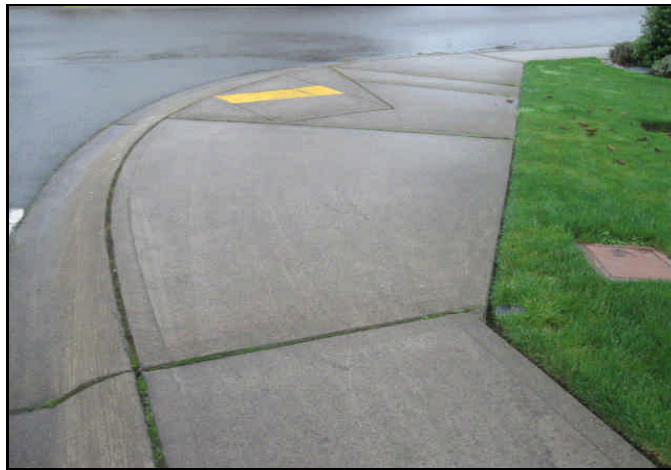
Comp #: 100 Concrete/Curb - Repair/Replace

Evaluation: We noted concrete to be in generally good condition with no significant damage or deterioration. No trip hazards were observed. Repair any trip and fall hazards (1/2" or larger displacement) immediately to ensure safety.

As routine maintenance, inspect regularly, pressure wash for appearance and repair promptly as needed to prevent water penetrating into the base and causing further damage.

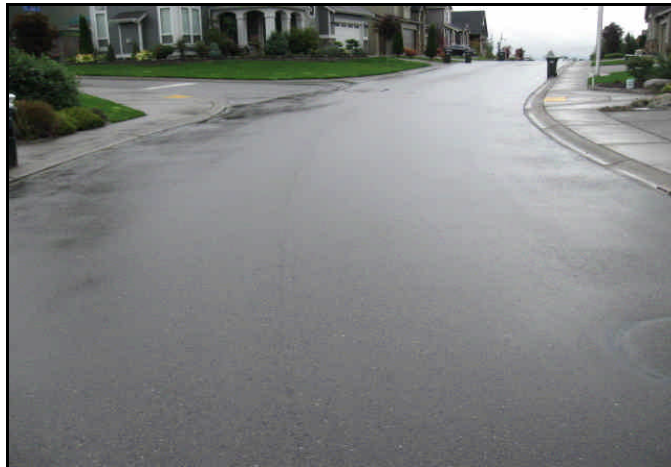
Evaluation: Overall good condition noted with no significant raveling (loss of binder), damage or deterioration observed.

Even with ordinary care and maintenance, plan for eventual large scale resurface (overlay) at roughly the time frame indicated below. As timing draws nearer, consult with asphalt vendor/consultant for recommendations and complete scope.

As routine maintenance, keep asphalt clean, free of debris and well drained; fill/seal cracks (hot rubberized crack fill) to prevent water from penetrating into the sub-base and accelerating damage.

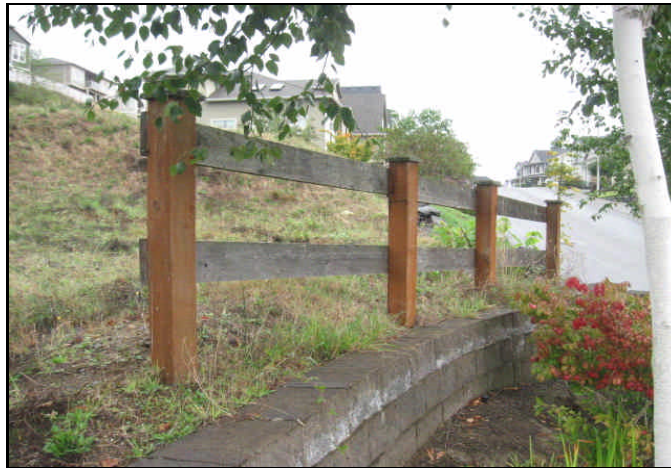
Based on the limited amount of post and rail fencing, maintenance, repair and replacement should be a smaller cost item and best suited to be handled through the operating budget, not reserves.

As routine maintenance, inspect regularly for any damage, repair as needed and avoid contact with ground and surrounding vegetation. Regular cycles of uniform, professional sealing/painting will help to maintain appearance and maximize life.

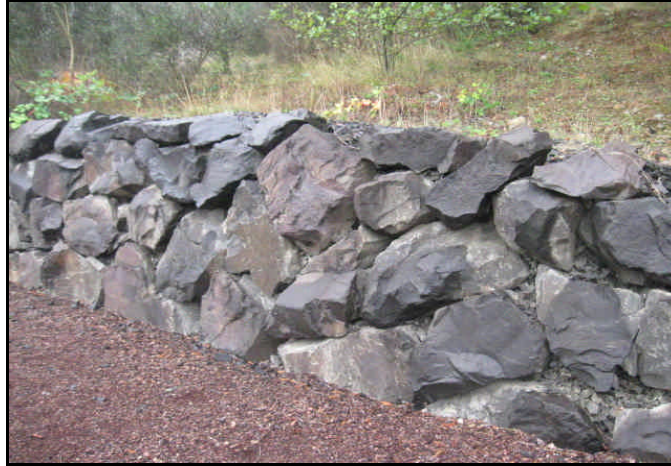
Evaluation: Fair condition noted with no significant crumbling or settling observed. Key to long lasting performance is proper original design and installation with adequate base and surrounding drainage.

Inspect regularly, repair as needed from operating budget. If shifting, crumbling, etc... is noted, consult with civil or geotechnical engineer or landscape architect for repair scope. At this time, no predictable expectation of large scale repairs or replacement; no basis for reserve funding.

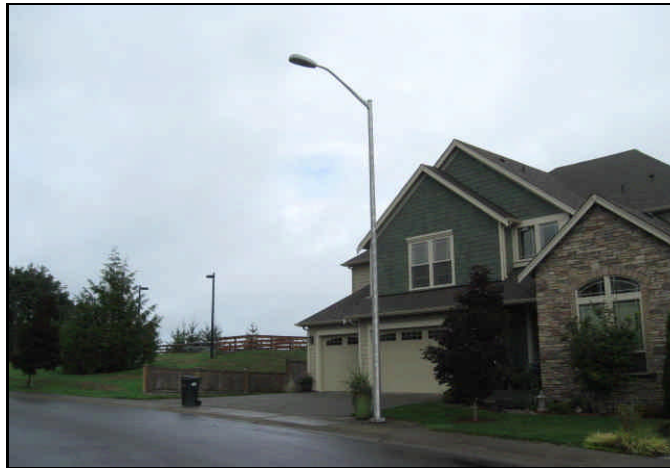
Comp #: 160 **Street Lights - Replace**

Evaluation: Good condition noted with no significant damage/deterioration observed or reported to us. Observed during daylight hours; assumed to be in functional operating condition.

This component represents replacement of street lights at private roads along Vista Verde Lane SW, Skyline Ridge Lane SW and Serenity Lane SW.

Best to plan for eventual large scale replacement at roughly the time frame indicated below for cost efficiency and consistent quality/appearance throughout association.

As routine maintenance, inspect, repair/change bulbs as needed.

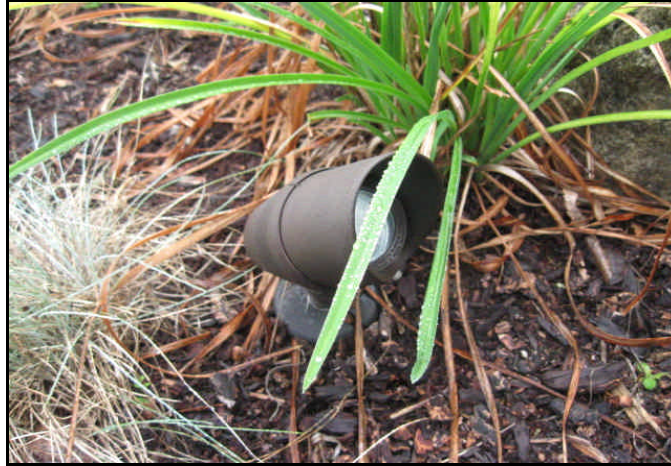
Comp #: 164 **Landscape Lights - Replace**

Evaluation: Mostly fair condition with no significant damage/deterioration noted during our site inspection; observed during daylight hours and assumed to be functional.

Small total quantity and individual replacement costs typically not at reserve funding threshold, therefore not suitable for reserve funding. Anticipate repairs/replacements as needed as part of annual operating budget.

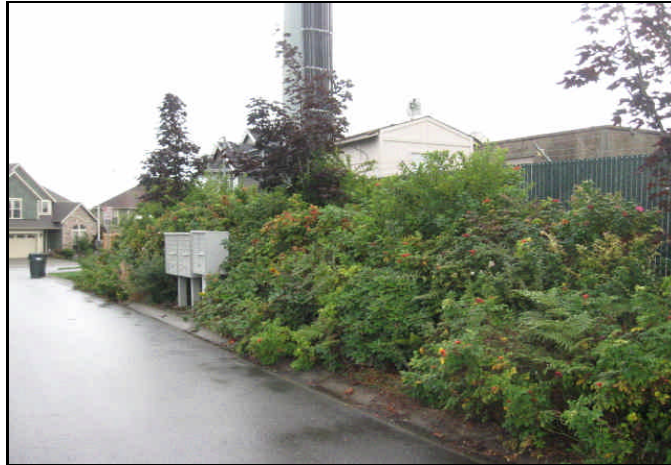
Evaluation: Common area landscaping is in poor, overgrown condition; maintenance of these areas has been reportedly deferred for some time.

Lower allowance to refurbish common area landscaping

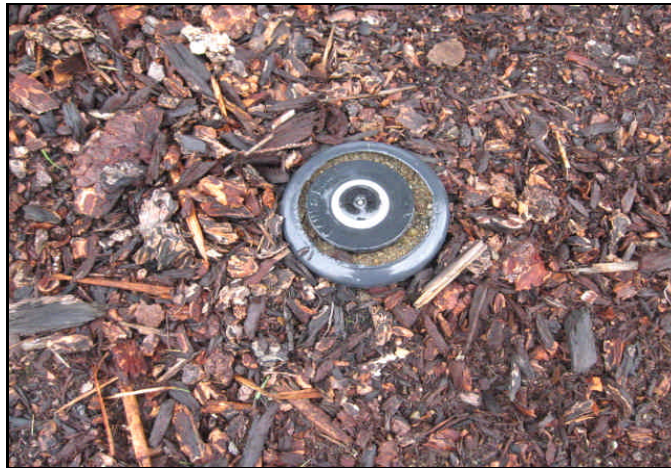
Comp #: 175 Irrigation System - Repair/Replace

Evaluation: No problems observed or reported during our inspection.

If properly installed and bedded without defect, the lines themselves are expected to be long-lived with no predictable expectation for replacement. In our experience however, as the community ages, large system renovations, repairs, zone reconfiguration, etc... become necessary. Therefore, we suggest a funding allowance within reserves to supplement the operating and maintenance budget. Ongoing items like head replacement, local valves, etc... should be handled as maintenance expense.

As routine maintenance, inspect regularly, test system and repair as needed. Follow proper winterization and spring start up procedures.

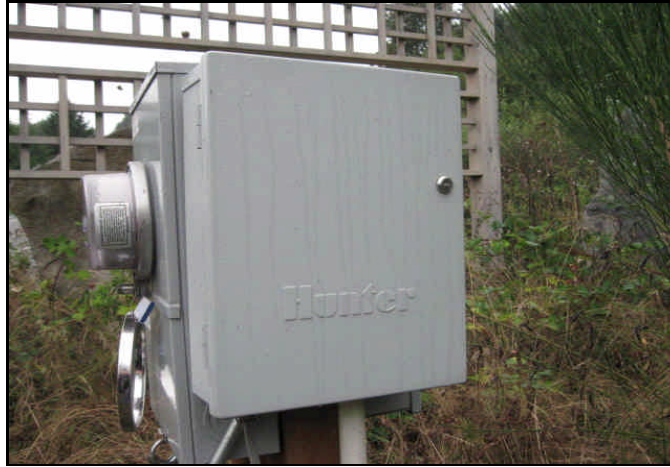
Comp #: 176 Irrigation Timeclocks - Replace

Evaluation: No problems observed or reported of irrigation timeclocks.

Eventual replacement will be needed due to parts obsolescence, technological upgrades, etc. If simply replacing existing clock in like kind, best suited to be handled as needed within the operating budget (less than \$500). If part of larger overall irrigation system renovation, see previous component for periodic reserve funding allowance.

Inspect regularly and repair/replace as needed.

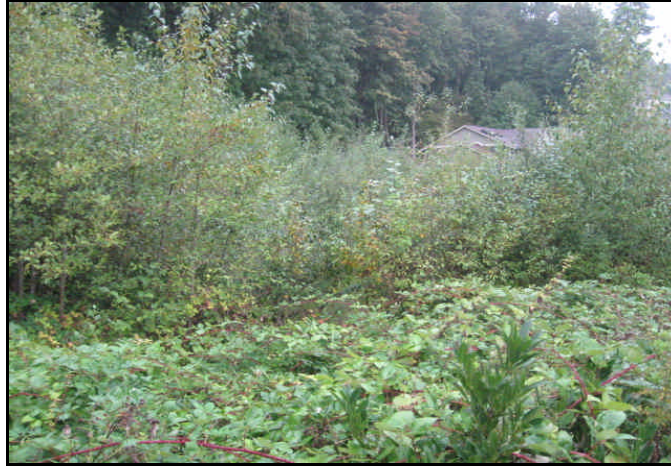
Useful Life:

Remaining Life:
0 years

Best Case: \$40,000.00

Lower allowance for one-time large scale refurbishment

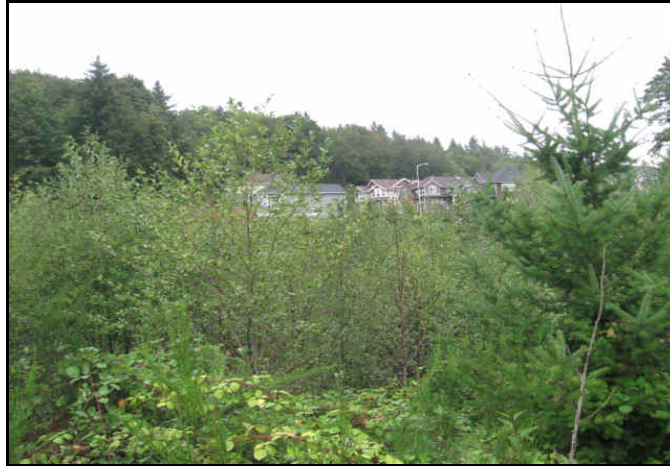
Evaluation: Ongoing maintenance program and close inspection is essential for performance and forestalling sediment removal. We assume ongoing vegetation and debris control as routine maintenance procedure. Guidelines for maintaining these systems are typically found on governing authority's (i.e. county or city) website.

Even with proactive cleanings/inspections, debris will eventually build up raising floor and warranting sediment removal and reconstruction to original design parameters per Department of Ecology guidelines. Best to plan for sediment removal and repair of ponds at the interval below; ponds should be professionally assessed before this time for more specific guidance.

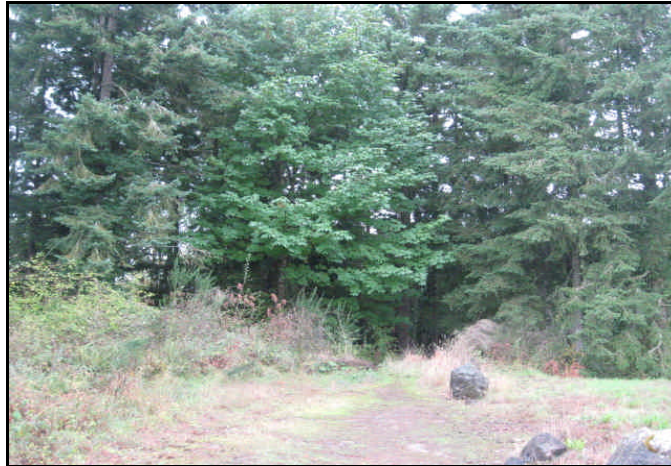
Location: Tract "L"

Evaluation: No problems observed of open space area in Tract "L". We recommend compliance with any and all governmental regulations regarding these areas. Typically, these open space areas are to remain undisturbed in a substantially natural state; periodic hazardous tree removal is typically allowed. No basis for large scale reserve funding suggested at this time.

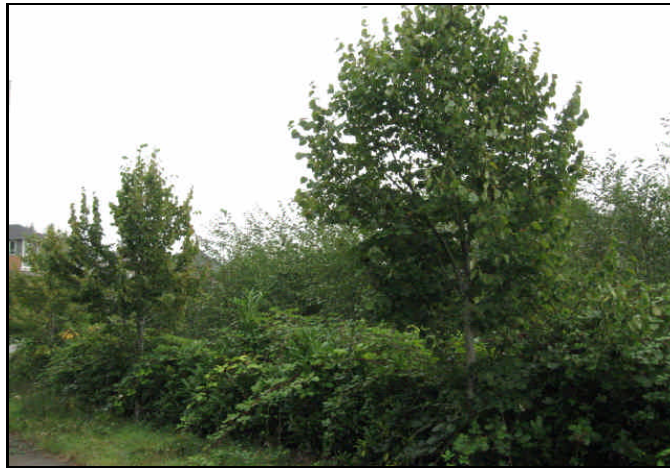
Comp #: 190 **Street Trees - Remove/Replace**

Evaluation: No specific problems observed or reported at this time of trees throughout community.

In similar communities, we have seen trees planted in common areas adjacent to roadways and sidewalks needing to be replaced at roughly the 10-15 year mark of life. The main reason for replacement being the wrong species of trees planted for a small growth area and generally less than favorable planting location. If the wrong species are planted, the root systems can cause damage to the nearby concrete and asphalt, or the trees themselves may die prematurely due to confined root systems.

If the community has not already done so, consult with a qualified arborist for a long-term plan for the care and management of the trees within the community, balancing aesthetics with protection of association assets. Reserve funding recommend at level indicated below for periodic tree removal/replacement needs. Track actual expenses and adjust in reserve study updates as indicated.

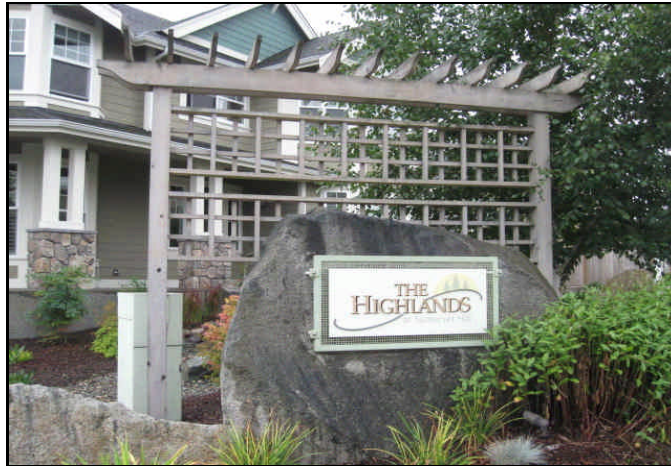
Useful Life:
20 years

Remaining Life:
12 years

Best Case: \$2,000.00

Lower allowance to repair/replace wood structures and refurbish metal signs

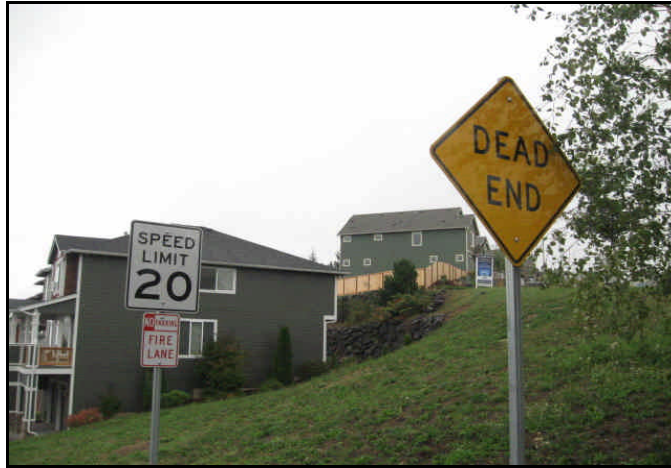
Useful Life:
20 years

Remaining Life:
12 years

Best Case: \$3,400.00

\$80/each (x42), Lower allowance to replace

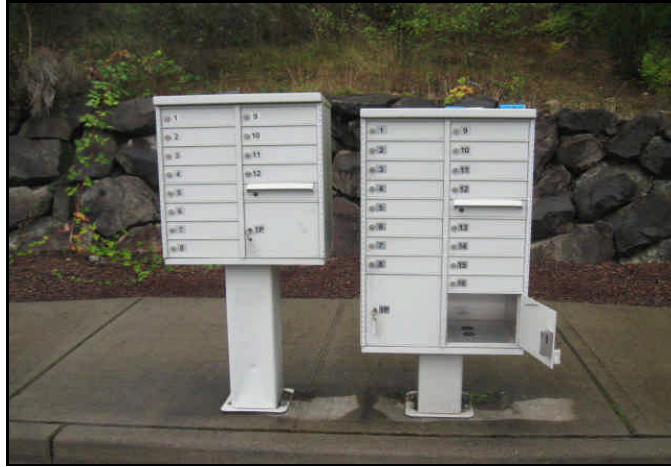
Useful Life:
20 years

Remaining Life:
12 years

Best Case: \$8,400.00

\$1,200/cluster stand (x7), Lower allowance to remove and replace
