Update "With-Site-Visit" Reserve Study

Sunrise Ridge/The Highlands at Somerset Hill Tumwater, WA

Report #: 23122-2
For Period Beginning: January 1, 2020
Expires: December 31, 2020

Date Prepared: July 24, 2019

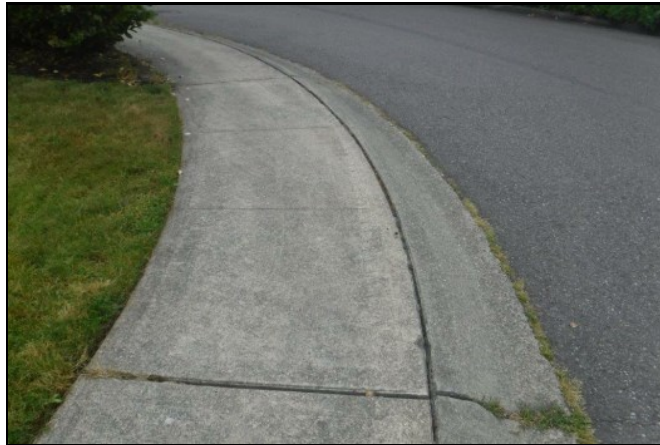
Comp #: 100 Concrete/Curbs - Repair/Replace

Comments: We noted dirt/grime on surfaces, however no major or widespread cracking/damaged noted of concrete rolled curbs and gutters. Repair any trip and fall hazards (1/2" or larger displacement) immediately to ensure safety.

In our experience, larger repair/replacement expenses emerge as the community ages. Although difficult to predict timing, cost and scope, funding allowance to supplement the operating/maintenance budget funded here for periodic larger repairs. Adjust as conditions, actual expense history indicates within future reserve study updates. As routine maintenance, inspect regularly, pressure wash for appearance and repair promptly as needed to prevent water penetrating into the base and causing further damage. Monitor tree roots nearby; consult with arborist for best practice.

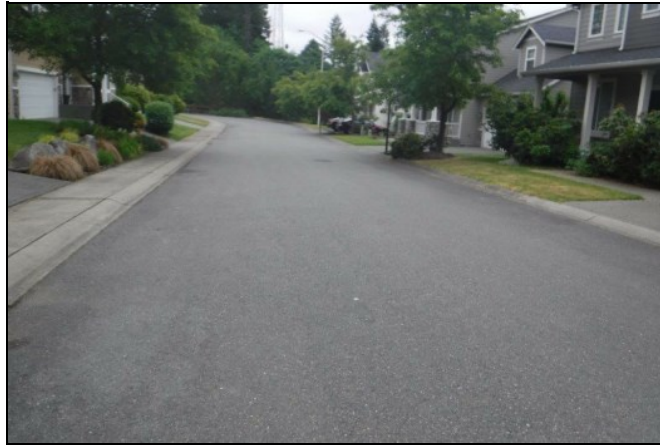
Comments: Like our previous site visit, we noted a couple local cracks and raveling but not widespread or significant at this time. No history of emulsion seal coating in this community with some local repairs/crackfilling having already occurred. As discussed with our board contact, routine sealcoat cycles are not part of the Association plans.

Funding included here for long term repave/resurface. The useful life here adjusted downward from previous reserve study as Association is not having sealcoating completed. When need to resurface is apparent within a couple of years, consult with geotechnical engineer for recommendations, specifications / scope of work and project oversight. As routine maintenance, keep surfaces clean and free of debris, ensure that drains are free flowing, repair cracks, and clean oil stains promptly.

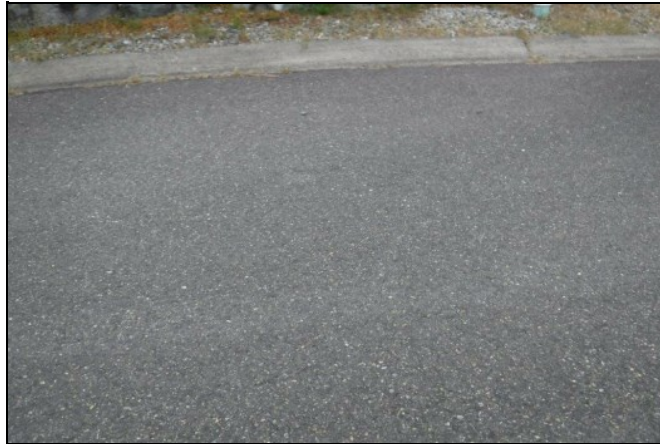
Comp #: 121 Asphalt - Clean/Repair/Crackfill

Comments: These surfaces have not had sealcoating in the past and according to our board contact no plans to begin sealcoat. We noted some raveling in areas and a couple cracks but no widespread or major damage noted at this time.

As discussed with board member, funding included here for periodic cleaning, repairing/crackfilling. This is in addition to annual inspections that might prompt work between these cycles. The costs/timing of this component can vary and should be adjusted as needed.

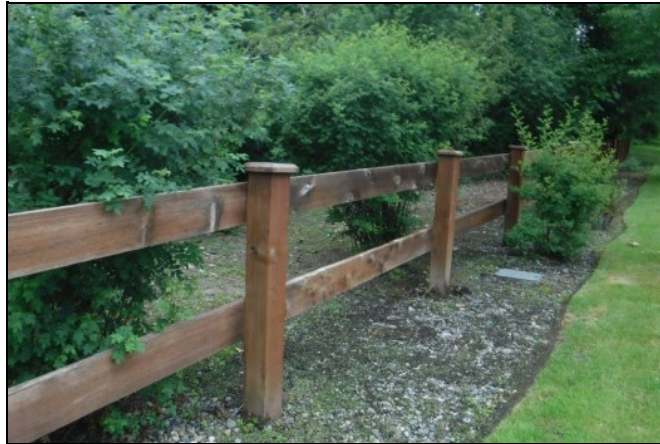
Comp #: 140 Double Rail Fence - Replace

Comments: No obvious major instability noted of sturdy, pressure treated wood fencing; pressure treated 6"x6" posts with 2" X 8" double horizontal boards.

Funding for replacement due to typical deterioration that will occur over time. As routine maintenance, inspect regularly for any damage and repair as needed. Avoid contact with ground and surrounding vegetation. Note: this same type of fencing with cyclone attached is included separately under component #142.
