**Comp #: 490 Clubhouse Plumbing - Repair/Replace**

# Marina

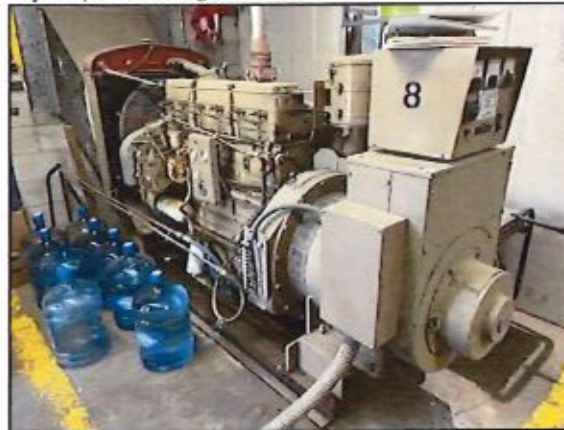
**Comp #: 2530 Emergency Generator - Replace**

Funding is provided for periodic major repairs of the generator.

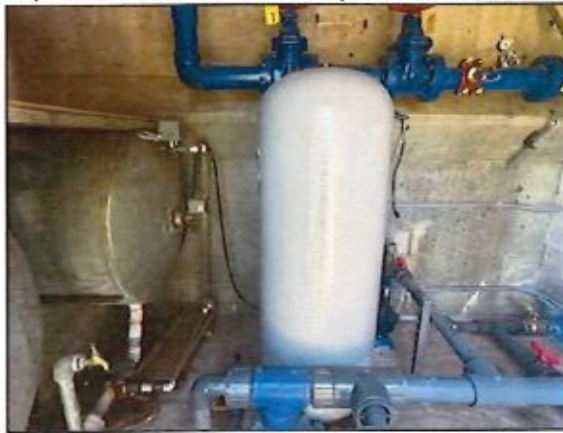
**Comp #: 3135 Hydropneumatic Tank - Replace**

**Comments:** Replacement of hydropneumatic tank recommended by NW Water Systems Plan 2025.

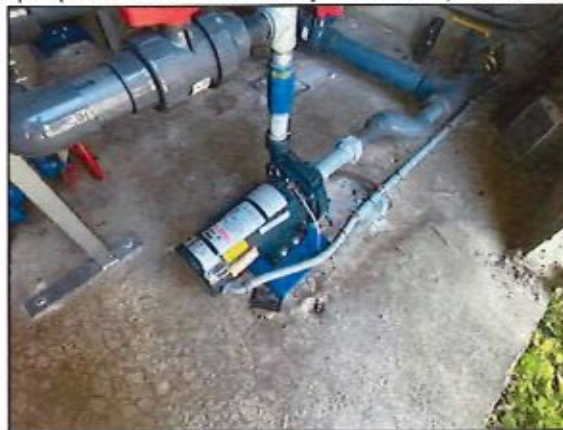
**Comp #: 3136 Pump, Booster - Replace**

**Comments:** Replacement of the pump booster recommended by NW Water Systems Plan 2025.

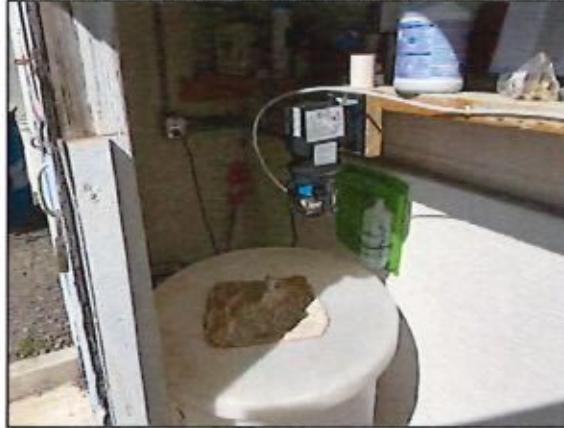
**Comp #: 3137 Pump, Chlorine - Replace**

**Comments:** Replacement of the chlorine pumps recommended by NW Water Systems Plan 2025.

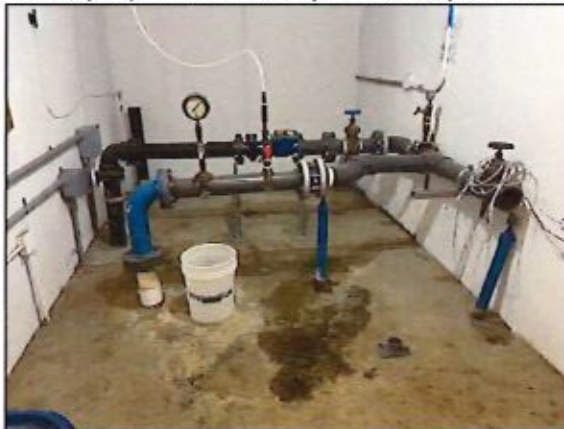
**Comments:** Replacement of the source pumps recommended by NW Water Systems Plan 2025.

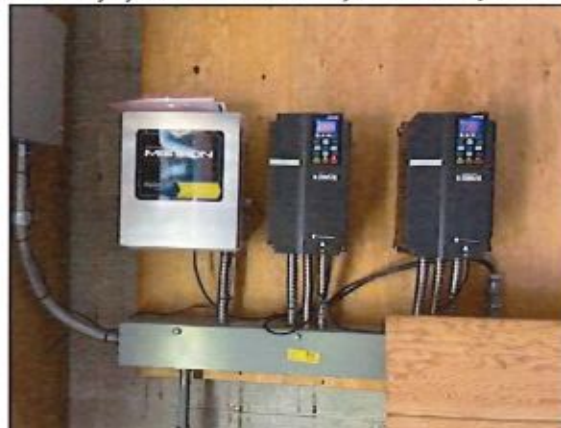
**Comp #: 3150 Telemetry system - Replace**

**Comments:** Replacement of the telemetry system recommended by NW Water Systems - Water System Plan 2025.

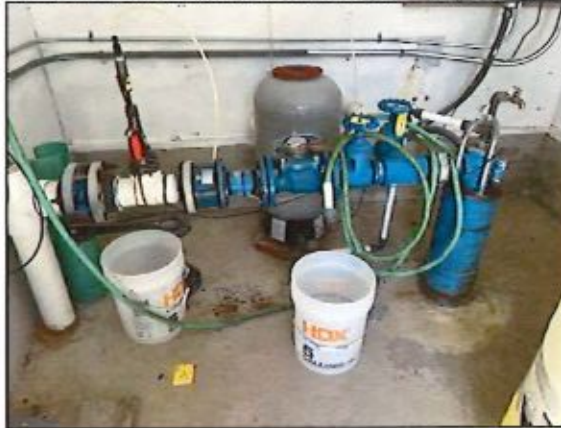
**Comp #: 3170 Well 2 - Replace**

**Comments:** Replacement of Well 2 recommended by NW Water Systems - Water System Plan 2025.

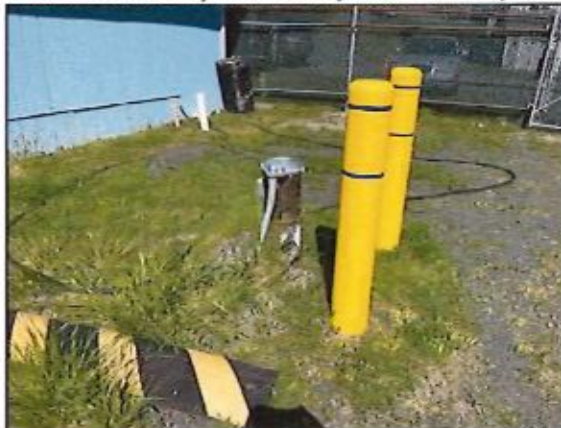
**Comp #: 3171 Well 3 - Replace**

**Comments:** Replacement of Well 3 recommended by NW Water Systems - Water System Plan 2025.

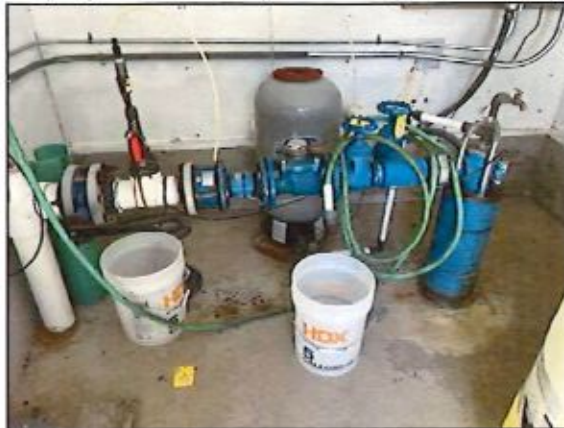
Comp #: 3175 Well 2 pump - Replace

Comments: Replacement of Well 2 pump recommended by NW Water Systems - Water System Plan 2025.

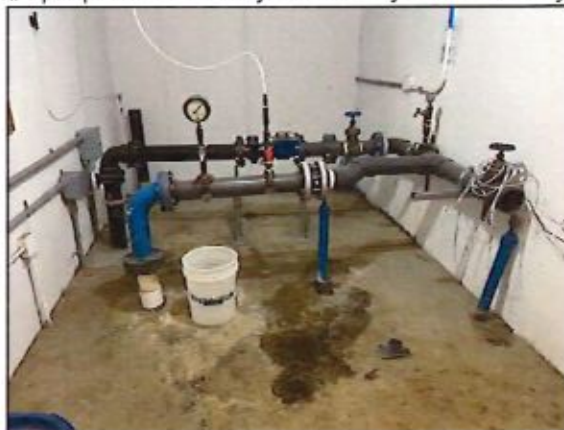
Comp #: 3176 Well 3 pump - Replace

Comments: Replacement of well 3 pump recommended by NW Water Systems - Water System Plan 2025.

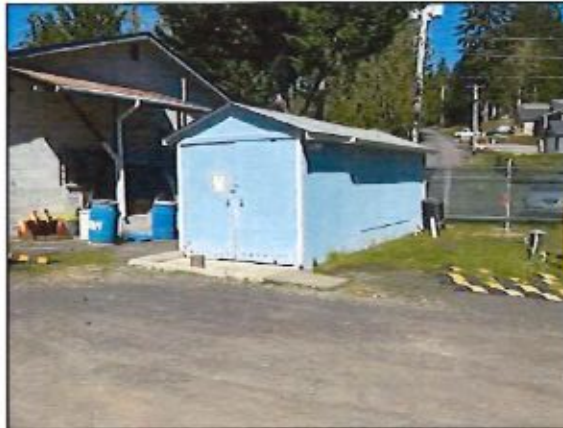
**Comp #: 3180 Building, Pump Houses - Replace**

**Comments:** Recommended replacement of pump house buildings recommended by NW Water Systems - Water System Plan 2025.

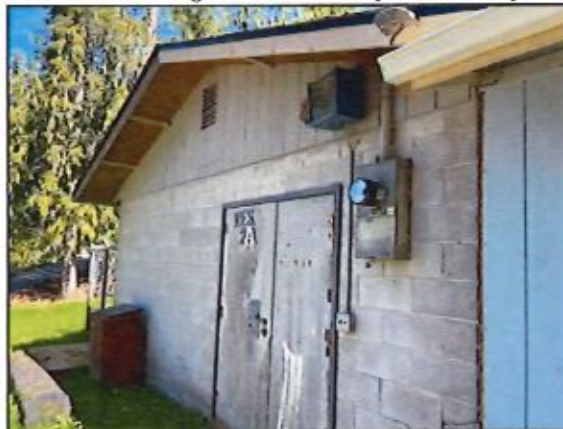
**Comp #: 3185 Building, Booster Station - Replace**

**Comments:** Replacement of booster station buildings recommended by NW Water Systems - Water System Plan 2025.
