Update “With Site-Visit” Reserve Study

Sunrise Ridge/The Highlands at Somerset Hill

Tumwater, WA

Report #: 23122-1

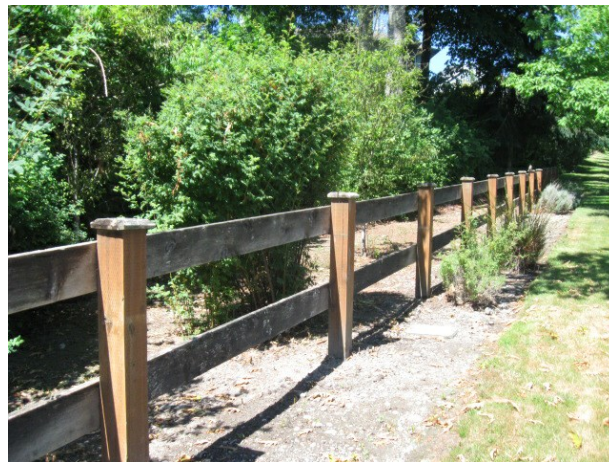
Useful Life:
20 years

Remaining Life:
7 years

Best Case: \$8,800 Worst Case: \$13,100
 Lower allowance Higher allowance
 Cost Source: ARI Cost Database: Similar Project Cost History

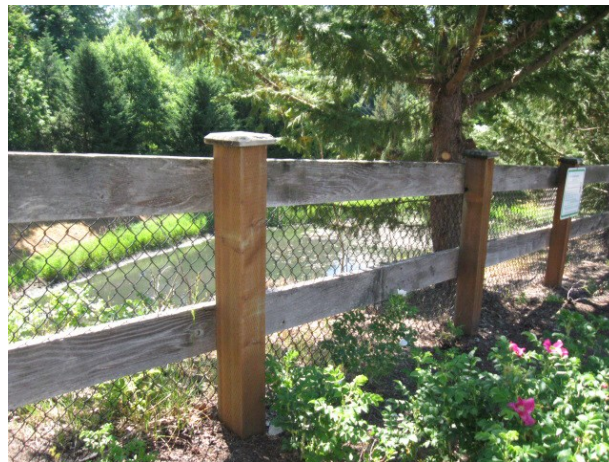
Useful Life:
20 years

Remaining Life:
8 years

Best Case: \$10,200
Lower allowance

Worst Case: \$15,300
Higher allowance

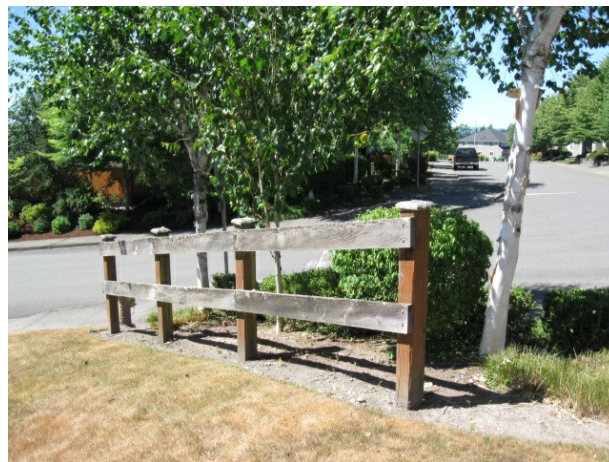
Useful Life:
4 years

Remaining Life:
3 years

Best Case:	\$6,000	Worst Case:	\$8,000
	Lower allowance		Higher allowance
Cost Source: ARI Cost Database/Similar Project Cost History

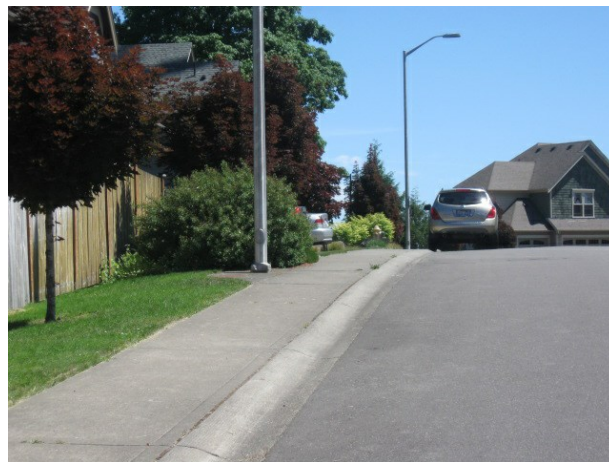
Useful Life:
20 years

Remaining Life:
8 years

Best Case: \$12,500

Worst Case: \$18,800

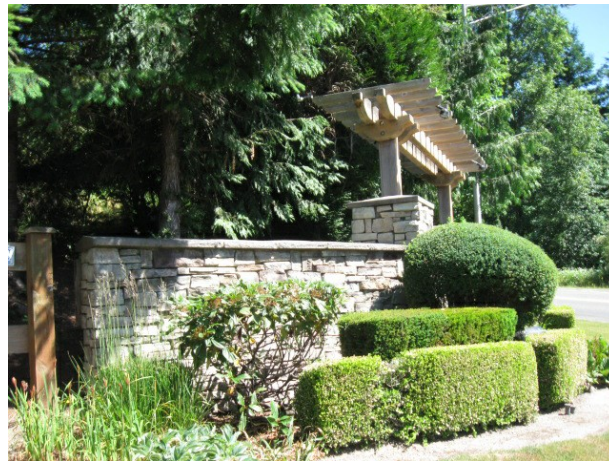
Useful Life:
5 years

Remaining Life:
3 years

Best Case: \$5,000
Lower allowance

Worst Case: \$10,000
Higher allowance

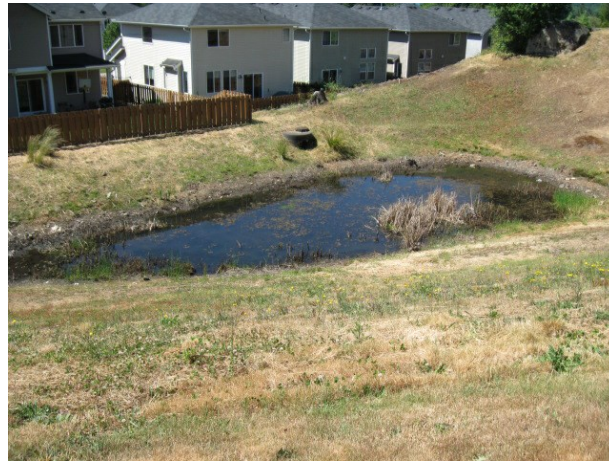
Useful Life:
4 years

Remaining Life:
2 years

Best Case: \$8,000 **Worst Case:** \$12,000
 Lower allowance Higher allowance
 Cost Source: ARI Cost Database: Similar Project Cost History

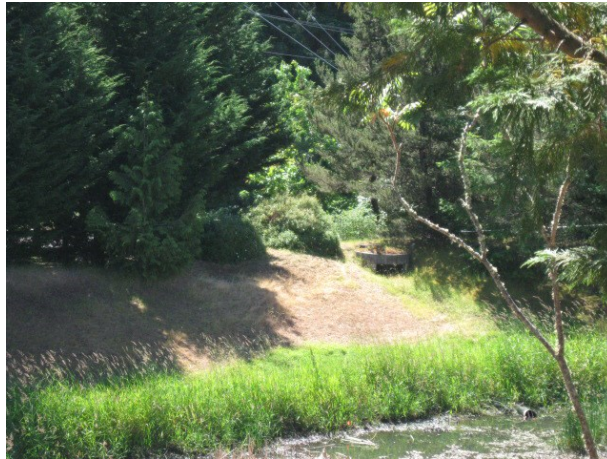
Useful Life:
2 years

Remaining Life:
0 years

Best Case: \$2,500
Lower allowance

Worst Case: \$4,500
Higher allowance

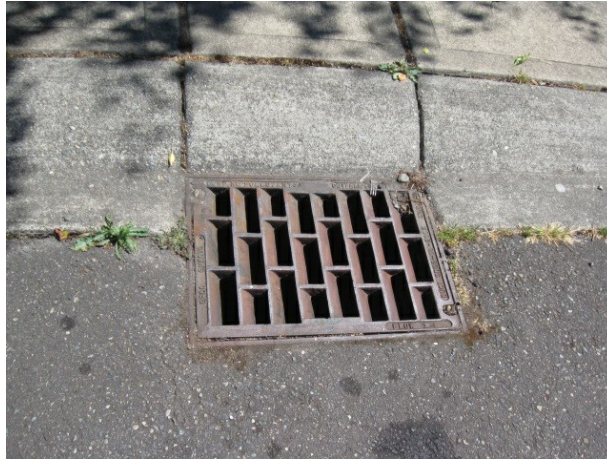
Useful Life:
3 years

Remaining Life:
1 years

Best Case: \$4,000

Worst Case: \$6,000

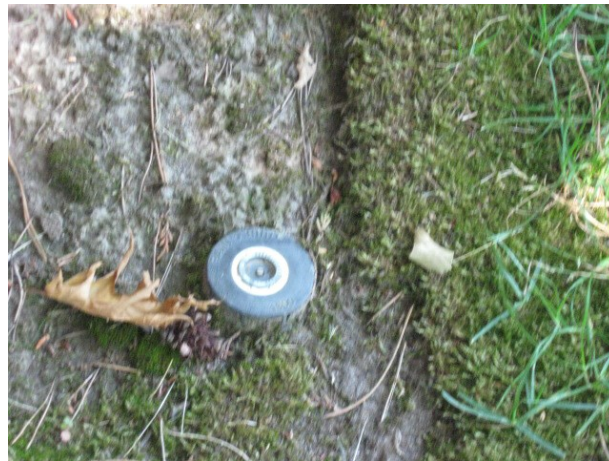
Useful Life:
5 years

Remaining Life:
4 years

Best Case: \$4,000 **Worst Case:** \$6,000
 Lower allowance Higher allowance
 Cost Source: ARI Cost Database: Similar Project Cost History

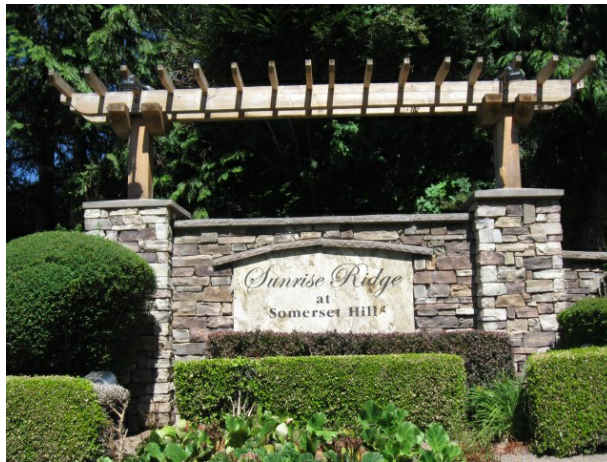
Useful Life:
20 years

Remaining Life:
8 years

Best Case: \$8,000

Worst Case: \$12,000

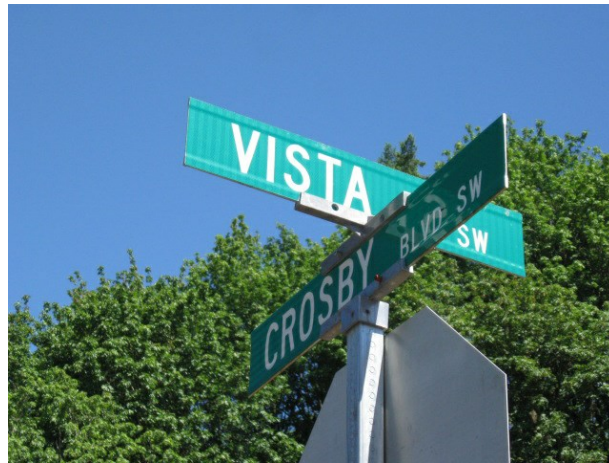
Useful Life:
20 years

Remaining Life:
9 years

Best Case: \$5,600

Worst Case: \$7,200

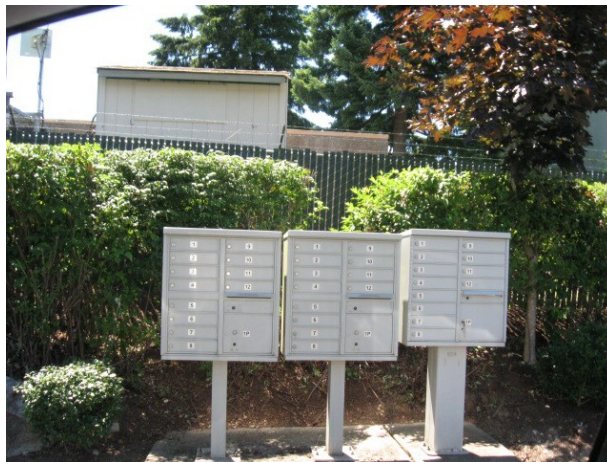
Useful Life:
20 years

Remaining Life:
8 years

Best Case: \$18,200
Lower allowance

Worst Case: \$23,800
Higher allowance

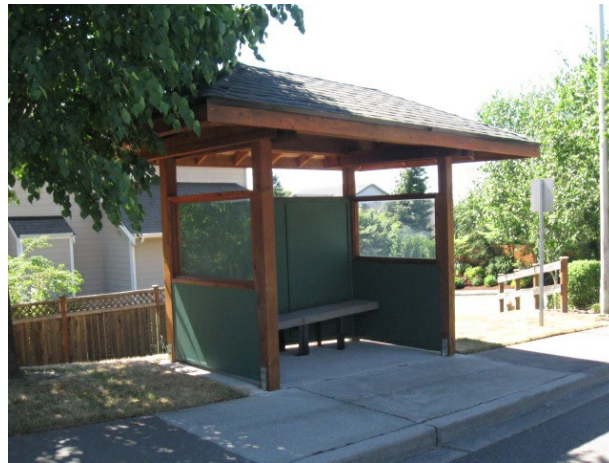
Useful Life:
20 years

Remaining Life:
6 years

Best Case: \$4,500

Worst Case: \$7,500
